DDAS Accident Report

Report date: 01/08/2006	Accident number: 430
Accident time: 10:30	Accident Date: 20/02/2001
Where it occurred: 4km N.W. Omhajer Village, Gash Barka	Country: Eritrea
Primary cause: Unavoidable	Secondary cause: Management control inadequacy
Class: Survey accident	Date of main report: 27/02/2001
ID original source: [Name removed]	Name of source: [Name removed]
Organisation: [Name removed]	
Mine/device: AT blast	Ground condition: Unsurfaced road
Date record created: 01/08/2006	Date last modified: 01/08/2006
No of victims: 1	No of documents: 4

REPORT OF BOARD OF INQUIRY INTO LANDMINE INCIDENT 20 FEBRUARY 2001

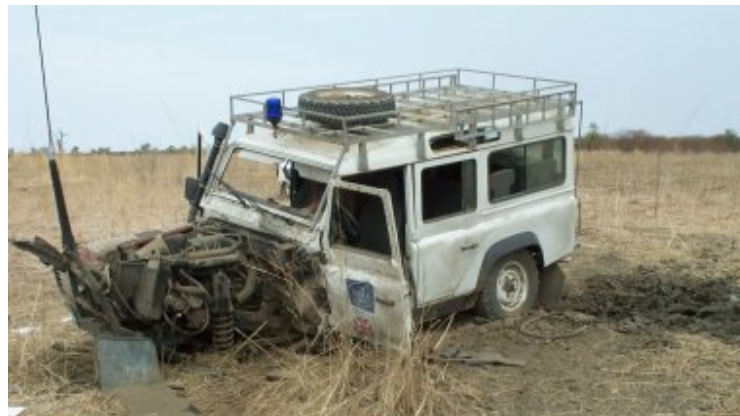
2. At approximately 11:00hrs on 20 February, a left hand drive Land Rover with add-on armour for mine protection, crewed by a [Demining group] Survey Team struck a landmine. The vehicle's front left wheel area and part of the engine were extensively damaged. There were no serious injuries.

71. The vehicles were travelling southeast along the unsurfaced track, at a speed of approximately twenty-five kilometres per hour. The lead vehicle was approximately twenty-five metres in front of the following vehicle; this estimation was taken from the [Demining group] commander of the second vehicle [name removed]. After driving for approximately five minutes, the leading vehicle drove over an anti tank mine, causing the front end of the Land Rover to become severely damaged.

101. The unsurfaced track should be flailed and UNMEE should provide assistance to recover the damaged vehicle.
