# **DDAS Accident Report**

Report date: 11/08/2006 Accident number: 432

Where it occurred: MF ID 1000552, na Country: Bosnia Herzegovina

Mine/device: PROM-1 AP Bfrag Ground condition: grass/grazing area

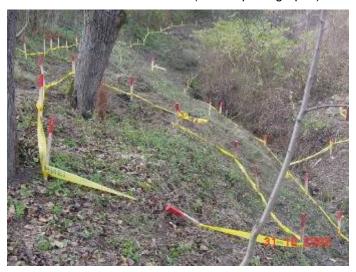
Photographs show the victim appeared to land on top of the marking tape. The area was a grassed incline alongside a wooden picket fence with woodland behind.

Photographs are confusing. A mature tree (45cm diameter approx) may have caused an obstruction in the clearance lane. Certainly a box around the tree was left, and parts of the victim were photographed on the marking for the edge of that box.

A photograph of the crater was present with the PROM circle easily seen, although the baseplate had not been recovered.

The photograph alongside appears to show the start of a lane and the deminer's red basestick, with the crater in front of the basestick. From this it is inferred that the victim initiated the mine in front of the marking.
