DDAS Accident Report

| Where it occurred: IMSMA ID: LK 133 Urumpirai Minefield, Kopay Division, Jaffna | Country: Sri Lanka |
| Class: Excavation accident | Date of main report: 16/10/2003 |
| Mine/device: P2Mk2 P4Mk1 AP blast | Ground condition: grass/grazing area hard |

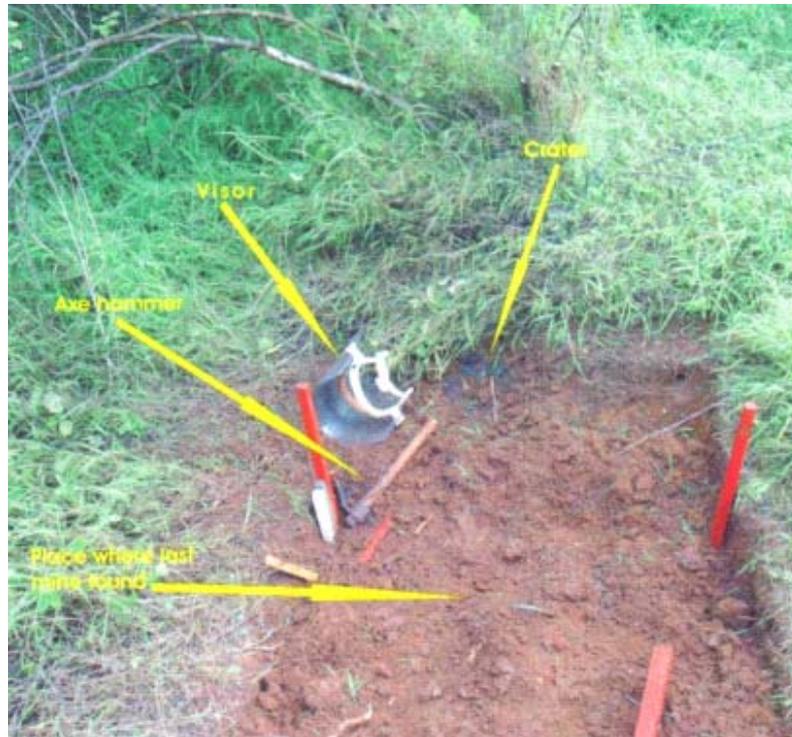
Narrative: The deminer [Name excised] was carrying out one man one lane manual demining drills in accordance with [Demining group] Sri Lanka manual demining SOPs for 100% excavation. He was using the axe hammer tool to excavate the face of his lane down to a depth of 15cm, when the detonation occurred. The mine detonated on the left hand side of his lane as he was using the axe hammer.

[The picture above shows the accident site]

[The type of mine involved was the Type 72 A, as] Determined by: Direct observation
Fragments found. The mine detonated completely leaving a crater of approx 50 cm across and 25 cm deep.

2. At the left hand side of the lane, the deminer excavated a block of soil when the blast occurred. In a debriefing after giving his statement, the deminer claimed that there was a block of hard soil at the left hand side of his lane. After 2 attempts to scrape it from the right to left, he tried to repeat that action from left to right and then the accident happened. This information leads to the possibility that the hard soil block pressed on the mine and caused the accident. But, a close look at the Axe-Hammer blade's edge implies that the deminer hit the mine with his digging tool. The blast marks and dust on the blade are spread from a point in the middle of the blade's edge, backwards toward the rear side of the Axe Hammer which indicated that the deminer was digging from top to bottom. Obviously this is a breach of the HALO Trust Standard Operating Procedures (SOPs).

4. The actual location of the mine was aside from the lane of the other mines that were found at the same lane (see figure 7). There is a high possibility that the deminer was expecting the mine to be more at the centre of his lane and therefore allowed himself to hit the ground hardly at the left side of his lane.
5. Both the Section Commander (S/CO) and the Task Commander (T/C) should have paid a closer attention to the way that the deminer was conducting his drills. The minefield is an open area therefore it is possible for the S/CO and T/C to see the deminers operating at all times.
6. The CASEVAC procedure was fast and good, but the reporting back to the office and to the O/IC was delayed due to poor coverage of the cellular phone net. In the end, the information was delivered by radio to the next minefield and from there by phone to the O/IC.

1. All operation in [Demining Group] Trust minefields will stop for the next 2 days and every deminer will go through refresher training in conducting a full excavation method of mine clearance.

2. An "actions on" paragraph be inserted into [Demining Group] Sri Lanka manual demining SOPs detailing the requirement to work evenly and systematically when excavating on hard soil

6. In cases of hard soil, the use of water should take place to soften the ground prior to excavating. This will prevent the use of force while using excavating tools.

7. In lanes that follow mine lines, especially when there is a clear picture of the distance between mines, deminers should avoid working with Axe-Hammer and use the smaller scraper instead.

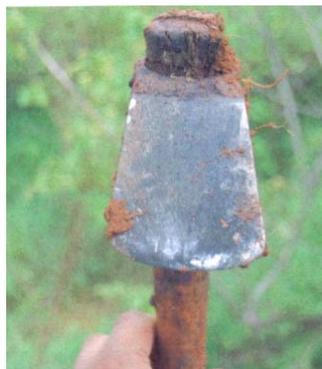
Equipment damaged: Axe Hammer, Metal axe head damaged by blast. No damage was caused to any [other] equipment. Some dust is visible on the outer face of the visor, as well as gloves and hammer scraper. Small blast marks on the hammer scraper. The deminer's body armour was unaffected by the blast.

[A picture of the tool after the accident is shown above.]
