DDAS Accident Report

INVESTIGATION OF MINE CLEARANCE ACCIDENT

At Kalat-e-Nayab Ghafor-MF-0069 Kohsan-HERAT on 7th February 2007

Report submitted: 12 February 2007

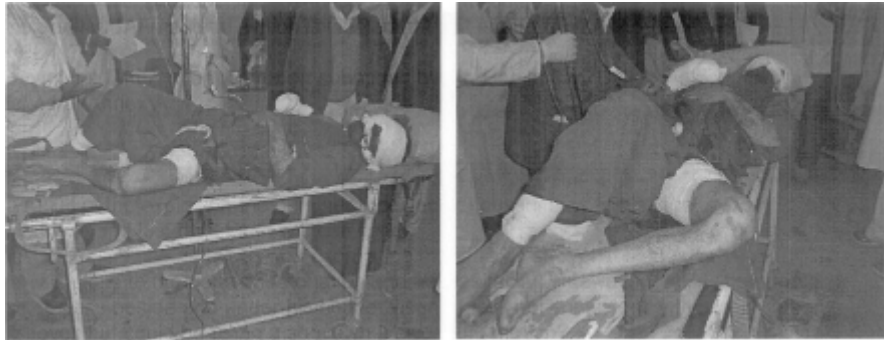
Injured Deminer Pictures

As a result of the explosion the deminer received serious injuries to his face, eyes right and left legs and lost right hand witness finger.

These injuries indicate that he was excavating the area by shovel at side position and his head was close to the point of detonation and he was facing sideways to allow the foreign object to pass beside and under his helmet visor. This is not consistent with proper use of the Shovel, but could be using a shovel in a sweeping motion?

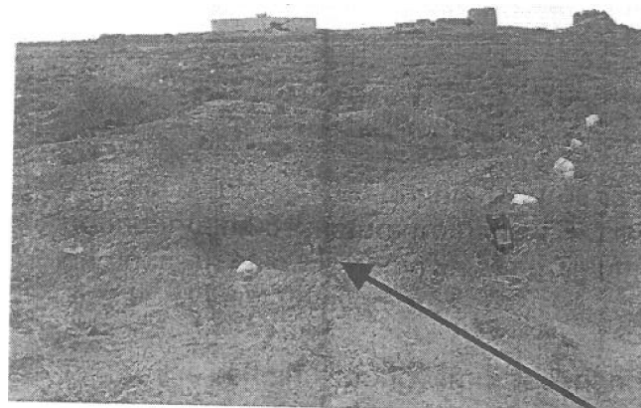
[The accident site.]

The accident occurred on the flat ground and seven meters far from the surveyed boundary and 31 meters from the TP-3 inside the minefield. The area shown in the photograph below is a known mine belt that stretched for 400 hundreds metres in both directions into surveyed area.

The soil is soft and spongy from recent heavy rain and contains small rocks. The investigating team believe the mine was buried not more than 3 cm and has been hit by shovel and caused the accident.

As the picture show the mine clearly, which is not deeper than 5cm and also the area is soft and suitable for prodding, therefore there is no need of shovel to be used, they must use the bayonet.

- All [Demining group] deminers must undergo refresh training on correct using of tools.
- All [Demining group] command staffs must undergo refresh training on their roles and responsibilities.
- All [Demining group] command group should not allowed deminer to use shovel instead of bayonet
- AMAC west recommended deducting/removing of shovel from demining tool kits, because, as per our experience it's third accident in western area, which happened during using of shovel.

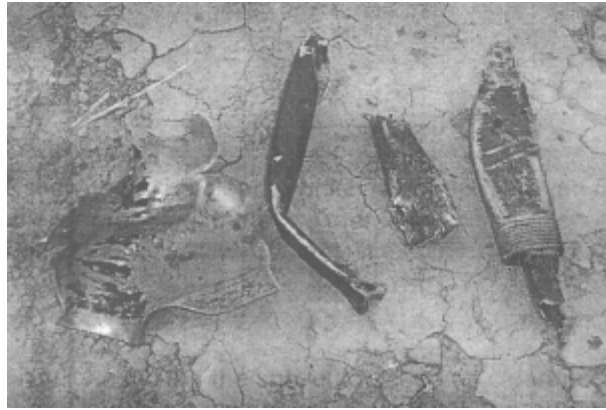
The victim deminer was using the shovel to speed up clearance and used it as a digging tool and the shovel is completely damaged. (refer to the below Photo.)

The tool broke into many parts (See Accident/Incident report) and the fragments may have been the cause of the Victim’s extensive injuries.

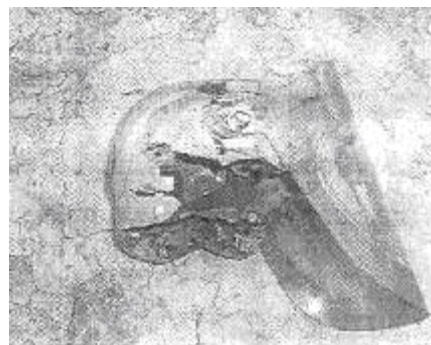
Photographs showing PPE damage [are too poor to reproduce. The visor is shown below].

The visor is the only PPE facing the target.

The Primary cause of this accident is listed as “Inadequate equipment” because it appears that the Victim was using a dangerous tool, and that this was the policy of his demining group. The secondary cause is listed as a “Field Control Inadequacy” because the victim was working with his visor raised and this error was not corrected.

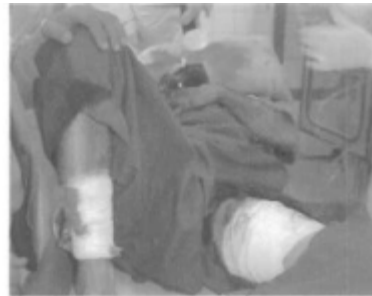
[Photographs showing the victim's injuries to head/eyes and legs.]

The positioning of the injured deminer's body at the time of the accident *confirms* the essential need to reposition the body for the various procedures during the location, confirmation and excavation phases. The visor and protective blast jackets/aprons are designed to be worn facing the explosive target. It is essential therefore that the deminer is trained to use the equipment in the manner they were designed for.

On locating a device, the deminer is strongly advised to adopt a lying position during the entire excavation procedure, this body position shields the entire body less hands from all blast and shrapnel.
