DDAS Accident Report

Report date: 28/12/2007	Accident number: 450
Accident time: 10:00	Accident Date: 05/11/2006
Where it occurred: Task # 130, Good Neighbourhood project, Hassankhail village, Bagram district, Parwan province	Country: Afghanistan
Primary cause: Field control inadequacy (?)	Secondary cause: Management/control inadequacy (?)
Class: Excavation accident	Date of main report: 19/12/2006
ID original source: OPS127/464-06	Name of source: UNMACA
Organisation: [Name removed]	
Mine/device: PMN-2 AP blast	Ground condition: dry/dusty soft
Date record created: 28/12/2007	Date last modified: 28/12/2007
No of victims: 1	No of documents: 3

Demining Investigation Report

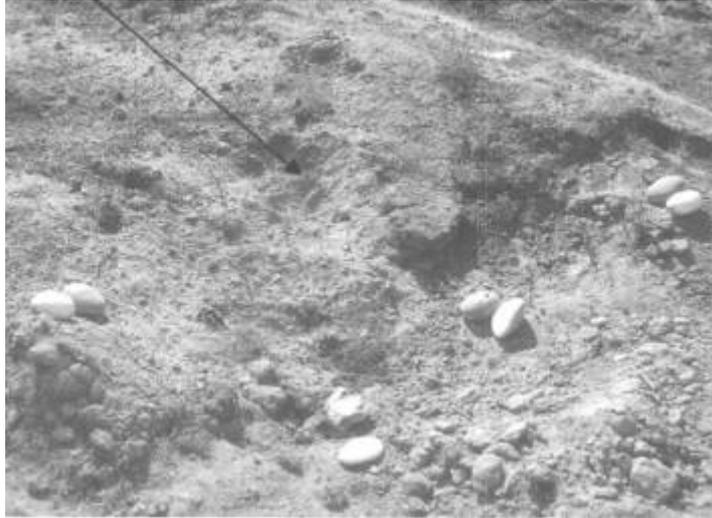
Picture of the accident site, showing shallow excavation.

1. The deminer has not maintained the safety excavation distance while he was excavating the located signal (exploded mine) and has started excavation from top of the signal, from this we can say that reading points have not been used for marking of the signal.

2. Observing the accident point made obvious that depth of the signal was near the ground surface and excavation depth of the signal (exploded mine) was reduced from 13 cm to 4 cm.

1. A revision course is to be held for the team members.
2. The deminers should use reading points for marking of the located signals, maintain the required clearance depth and safety excavation distance while excavating the located signals and the team command group should control them.
3. The team command group should strictly control the deminers to work in accordance with the procedure.
4. The deminers should not work with the bayonets that its use has been prohibited; they should work with the standard bayonets.
5. The Internal QA/QC conducting and recording systems should be improved in the team level and NGO level.
6. The team deminers should not work on the located signals by portable shovels, which is against the set procedure.

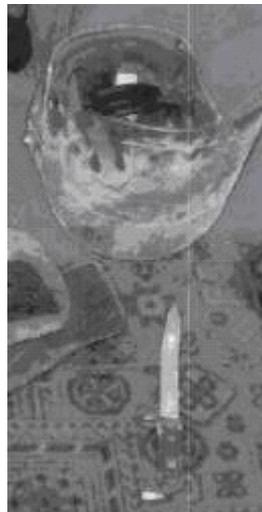
Description of equipment damage: the victim's bayonet was bent.

The picture shows an AK bayonet and dirty visor.

3. When we asked about bayonet of the deminer, they showed us a Russian made bent bayonet, which its use has been prohibited. They pretended that the explosion has bent the bayonet. If the deminer had worked with that bayonet either his right hand was cut or seriously injured, but from injuries of the deminer hand we can say that the deminer has excavated the signal (exploded mine) by portable shovel not by the bayonet.

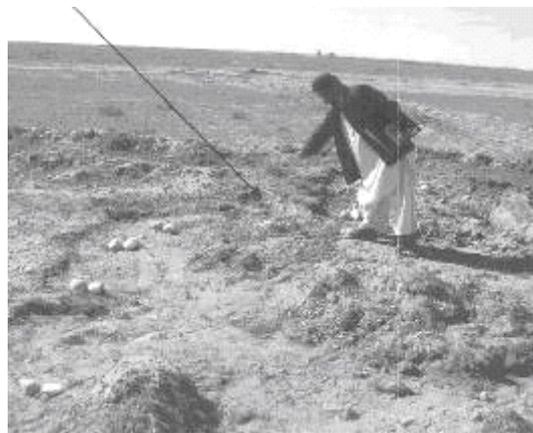
[The photograph shows an investigator at the site – not wearing PPE.]
