DDAS Accident Report

| Where it occurred: Task # 1182, Lataband Village, Talugan District, Takhar Province | Country: Afghanistan |
| Class: Excavation accident | Date of main report: 17/07/2006 |
| Mine/device: PMN-2 AP blast | Ground condition: dry/dusty grass/grazing area hard |

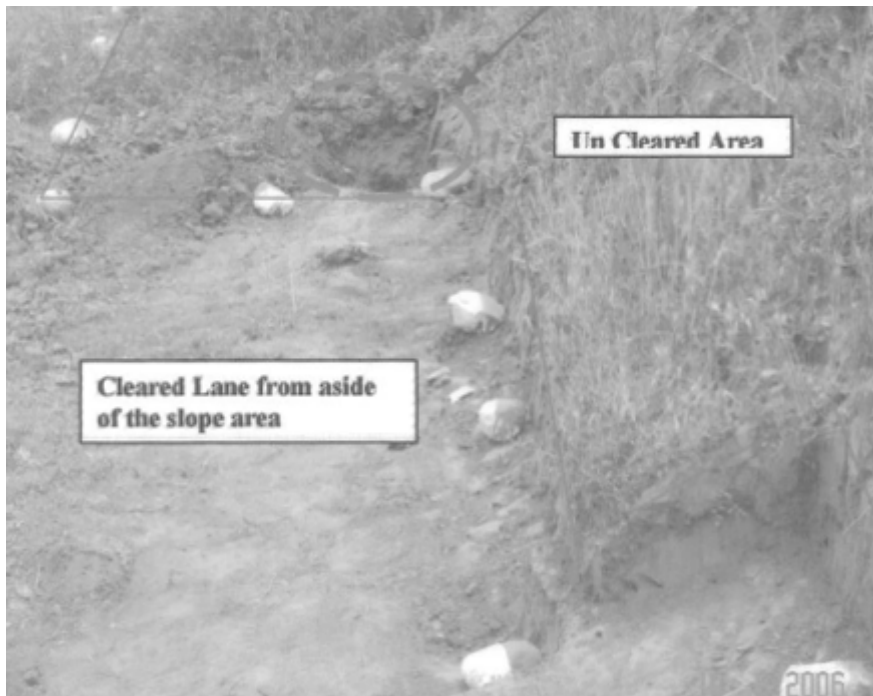
As it is explained that the deminer had worked from aside the slope area where the space was very tight and he couldn't use his hand freely the height and the hardness of the ground and the tightness of the space made him to use the trowel vertically

“Cleared Lane from aside of the slope area”

If the team leader of the team arranged the working lane from down to up side of the slope area the mine may disclose easily and cause no casualty. [A poor photograph actually showed the lane working across the slope side-to-side (slightly downward)]. The actual route of the working lane, which was arranged by the team leader for the deminer to work that caused the accident by doing such.

5. The team leader is recommended to manage the working lane from down to up side of the slope area not from sideways of the hill or slope area up to down position.

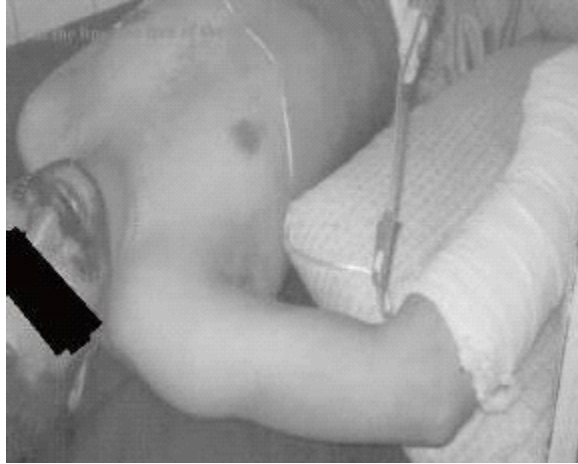
[The photograph shows the right arm bandaged to the elbow and blackened fragmentation injury (unburned TNT) on the victim's chin extending to his nose.]

One deep wide and serious injury on his right hand with tissue defect and multiple fractures

Upper lip erosion and oedema which is not serious.

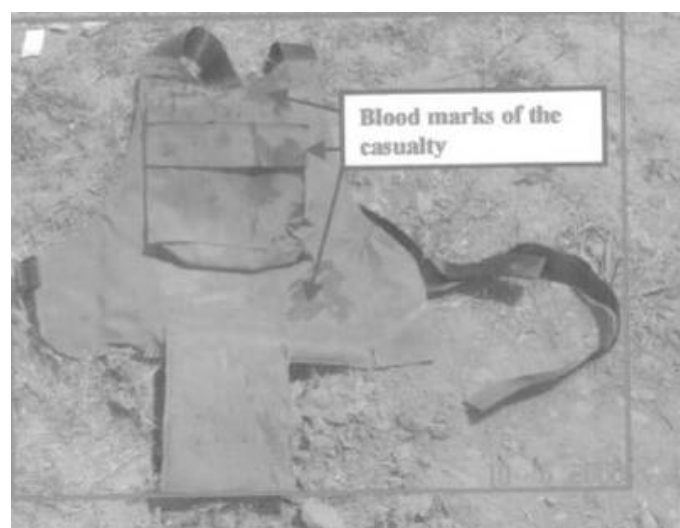
The demining group's continued use of inadequate protection and tools that do not meet the IMAS are the "Management Control Inadequacy" listed as the secondary cause of the accident.

[The photograph shows the minimal frontal protection with no collar to interface with the lower part of the visor, so leaving the throat exposed even when the visor is worn correctly.]
