# DDAS Accident Report

<b>Report date:</b> 02/01/2008	<b>Accident number:</b> 453
<b>Accident time:</b> 09:30	<b>Accident Date:</b> 09/06/2006
<b>Where it occurred:</b> Task # 1182, Lataband Village, Talugan District, Takhar Province	<b>Country:</b> Afghanistan
<b>Primary cause:</b> Field control inadequacy (?)	<b>Secondary cause:</b> Management/control inadequacy (?)
<b>Class:</b> Excavation accident	<b>Date of main report:</b> 17/07/2006
<b>ID original source:</b> 01/01/04 out 237-06	<b>Name of source:</b> UNMACA
<b>Organisation:</b> [Name removed]	
<b>Mine/device:</b> PMN-2 AP blast	<b>Ground condition:</b> dry/dusty grass/grazing area hard
<b>Date record created:</b> 02/01/2008	<b>Date last modified:</b> 02/01/2008
<b>No of victims:</b> 1	<b>No of documents:</b> 3

Sub: [Demining Group] Demining accident report

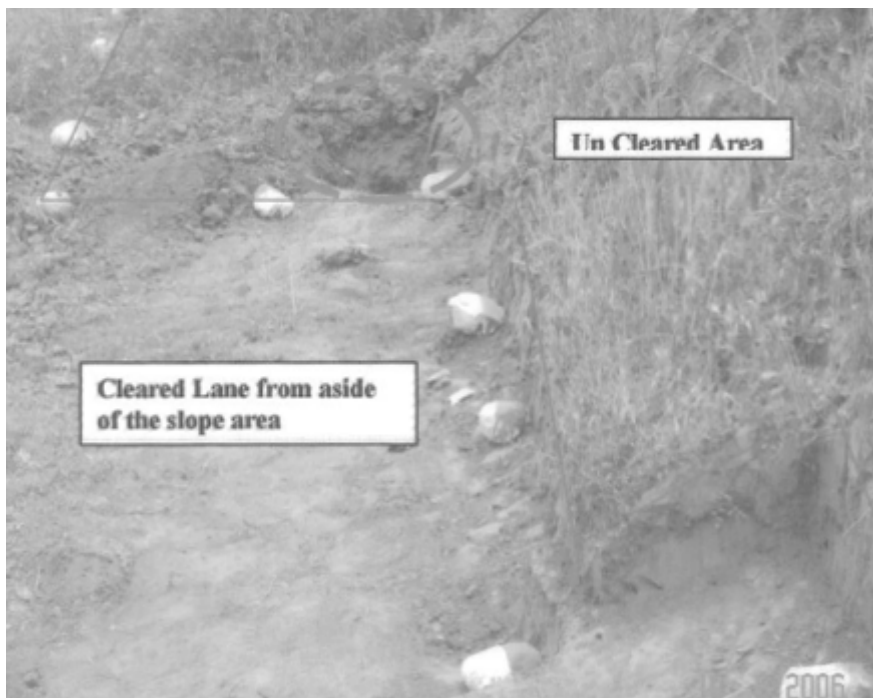
As it is explained that the deminer had worked from aside the slope area where the space was very tight and he couldn't use his hand freely the height and the hardness of the ground and the tightness of the space made him to use the trowel vertically

“Cleared Lane from aside of the slope area”

If the team leader of the team arranged the working lane from down to up side of the slope area the mine may disclose easily and cause no casualty. [A poor photograph actually showed the lane working across the slope side-to-side (slightly downward)]. The actual route of the working lane, which was arranged by the team leader for the deminer to work that caused the accident by doing such.

5. The team leader is recommended to manage the working lane from down to up side of the slope area not from sideways of the hill or slope area up to down position.

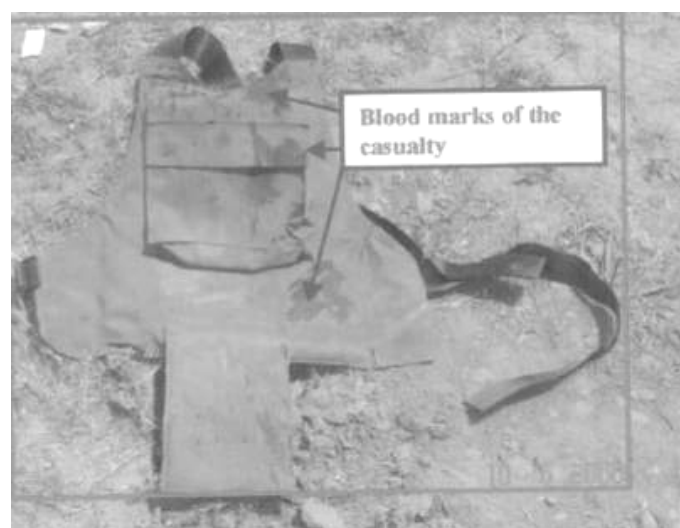
The demining group's continued use of inadequate protection and tools that do not meet the IMAS are the "Management Control Inadequacy" listed as the secondary cause of the accident.

[The photograph shows the minimal frontal protection with no collar to interface with the lower part of the visor, so leaving the throat exposed even when the visor is worn correctly.]
