DDAS Accident Report

Report date: 03/01/2008	Accident number: 455
Accident time: 10:30	Accident Date: 02/05/2006
Where it occurred: Khoshal Khan Hostel Complex, Dasht-i-Padola, Chehelstoon, Kabul City	Country: Afghanistan
Primary cause: Field control inadequacy (?)	Secondary cause: Unavoidable (?)
Class: Mechanical excavation	Date of main report: 29/05/2006
ID original source: Ops-27/266/06	Name of source: UNMACA
Organisation: [Name removed]	
Mine/device: M-19 AT blast	Ground condition: dry/dusty
Date record created: 03/01/2008	Date last modified: 03/01/2008
No of victims: 0	No of documents: 2

Mechanical Demining Accident at Chilston - 2 May 2006

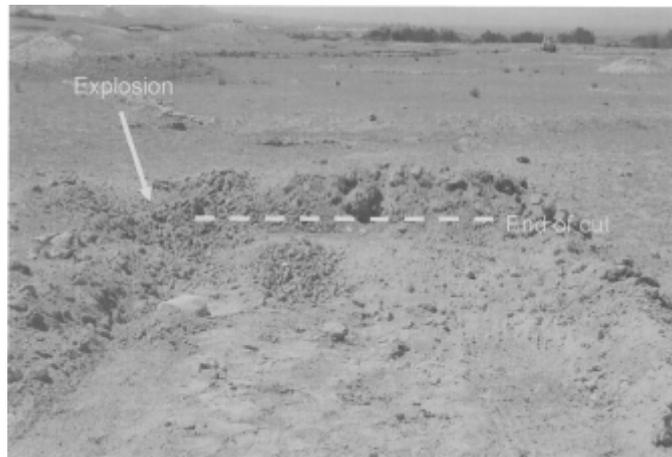
3.1. At approx 10:30, [Name removed], an operator with five years experience on the Case 721, was taking a cut when an AT mine exploded at the left front edge of his Gill bucket (see below).

5.1. From the limited damage to the bucket and from the position of the crater relative to the lane, it seems likely that the mine detonated in front of the bucket rather than below it — possibly as a result of indirect pressure.

5.2. It appears that the depth of the cut was less than the 30cm minimum that had been ordered: a measurement taken 1.5 metres back from the seat of the explosion suggested that the actual depth of the cut was around 21 cm. The ground on the site, whilst soft, is slightly undulating, which makes it more difficult for operators to maintain the correct depth. In this case, the loader had just crossed a road of hard-packed earth, and it is possible that the operator had failed to regain the correct depth before he encountered the mine.

6.2. Loader operators and team leaders must ensure that the minimum depth of cut is 30cm below the original ground level. Where the ground is sloping or uneven the depth of cut should be greater than 30cm to allow sufficient margin for error. The Chilstoon site includes a number of trenches and ditches which may have been partly filled in since the mines were laid; team leaders are to take particular care when excavating these.

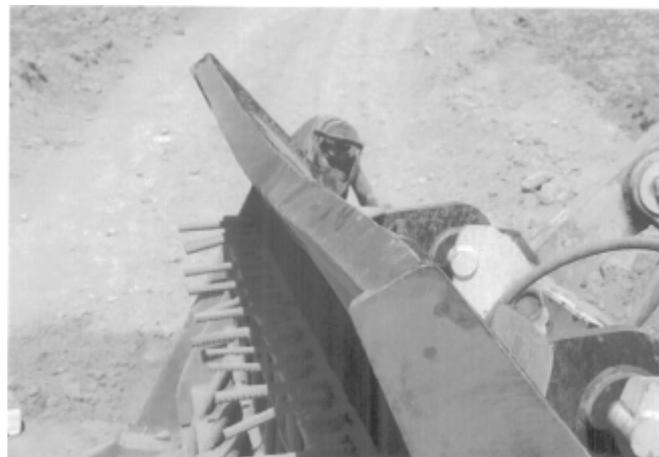
3.3. There were no casualties. The damage to the bucket was minimal — specifically the left-hand tooth was snapped off, and landed 180 metres away;

3.3.2. The mole board was bent back about 5 cm out of true:

3.3.3. Two small welds were broken: one attaching the Gill system to the inside of the bucket (top left), and one attaching a lifting eye on the left side of the bucket.
