DDAS Accident Report

Report date: 04/01/2008	Accident number: 459
Accident time: 08:57	Accident Date: 10/07/2004
Where it occurred: MF ID 11162, "Tvornica -BNT- Slimena 1", Slime Village, Travnik	Country: Bosnia Herzegovina
Primary cause: Management/control inadequacy (?)	Secondary cause: Field control inadequacy (?)
Class: Vegetation removal accident	Date of main report: 19/07/2004
ID original source: Broj: 02-OK-15- 3647/04	Name of source: BHMAL WL
Organisation: [Name removed]	
Mine/device: PROM-1 AP Bfrag	Ground condition: metal fragments metal scrap trees woodland (bush)
Date record created: 04/01/2008	Date last modified: 04/01/2008
No of victims: 4	No of documents: 1

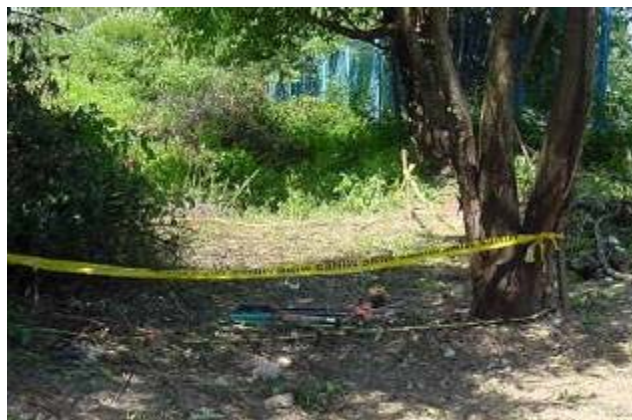
The most risky part of the demining task is the area between the asphalt areas in the back yard of the factory. The area towards the fence is tilted [sloping]. These tilted areas are used (the factory was working at the time of the clearance operation) for the disposal of metal waste from the factory and branches from the neighbouring trees. On this risky area, the vegetation is dense and high with grass, bushes and some trees. At the time of accident, the weather was clear and sunny, temperature 20 degrees.

[The site of the accident.]

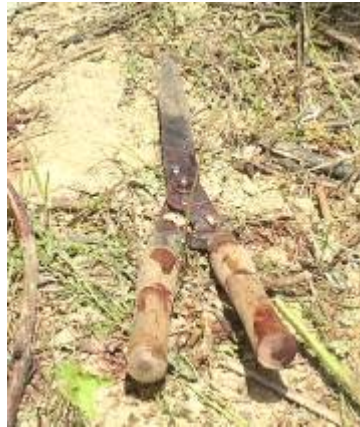
not significantly reduce the injuries. Two shears were found near the scene of the accident, two secateurs, a small saw and an antenna for tripwire detection. No prodders and no shovels were found. However, the team leader claimed that the deminers had PPE, detectors, prodders, shovels, shears and base sticks.

[Blood stained shears found near the victims.]
