# DDAS Accident Report

<b>Report date:</b> 04/01/2008	<b>Accident number:</b> 460
<b>Accident time:</b> 08:21	<b>Accident Date:</b> 16/09/2004
<b>Where it occurred:</b> MF ID 11290, Odmutsko Polje 1 - Grebnice, Domaljevac-Samac	<b>Country:</b> Bosnia Herzegovina
<b>Primary cause:</b> Management/control inadequacy (?)	<b>Secondary cause:</b> Field control inadequacy (?)
<b>Class:</b> Excavation accident	<b>Date of main report:</b> 05/10/2004
<b>ID original source:</b> None	<b>Name of source:</b> BHMAL WL
<b>Organisation:</b> [Name removed]	
<b>Mine/device:</b> PROM-1 AP Bfrag	<b>Ground condition:</b> leaf litter metal scrap wet woodland (bush)
<b>Date record created:</b> 04/01/2008	<b>Date last modified:</b> 04/01/2008
<b>No of victims:</b> 2	<b>No of documents:</b> 1

## Accident report

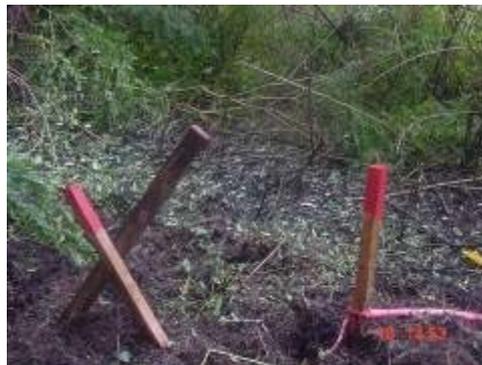
[Accident site (crater in centre).]

The area around the accident has been disturbed after the accident and some pegs and tapes were obviously placed after the accident.

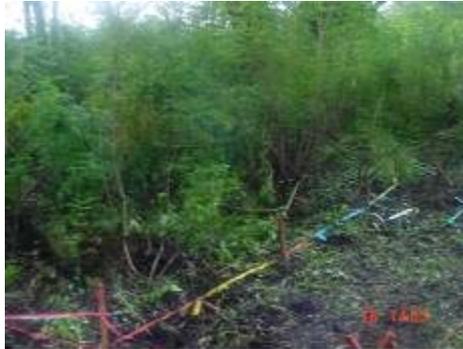
The work-site had not been established according to the National Standards of Bosnia and Herzegovina and the SOPs. The administrative areas were established on the safe distance, but the area was not properly marked.

[Vegetation at the site.]
