# DDAS Accident Report

AMAC HERAT INVESTIGATION ON EXPLOSIVE ORDNANCE ACCIDENT AT SHAYDAEE AMMUNITION COLLECTION POINT, HEART, ON 5TH SEPTEMBER 2006

EXPLOSIVE ORDNANCE ACCIDENT AT SHAYDAEE AMMUNITION COLLECTION POINT

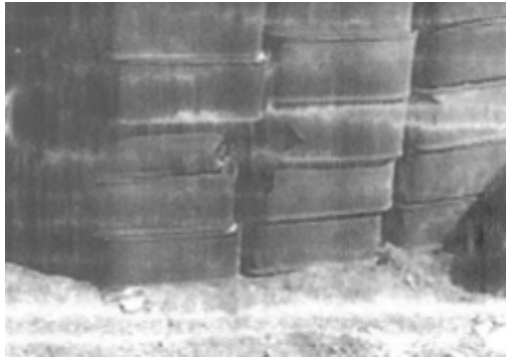
General area of the accident site showing debris and location of secondary explosion

It is probable the secondary explosion occurred as a fuse ejected from the box struck the long stack of fuse boxes on the right side of the worksite, detonating and opening two containers. The explosion was not sufficient to cause sympathetic detonation. If this occurred the situation could have been far more serious.

Stack of other fuses on right side of worksite showing secondary explosion located at rows two and three from the bottom

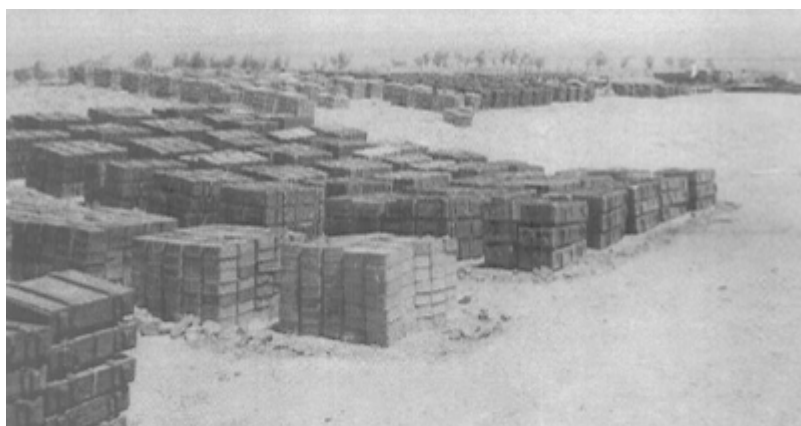
Illustration 1 — Photograph of Sheydayee general layout

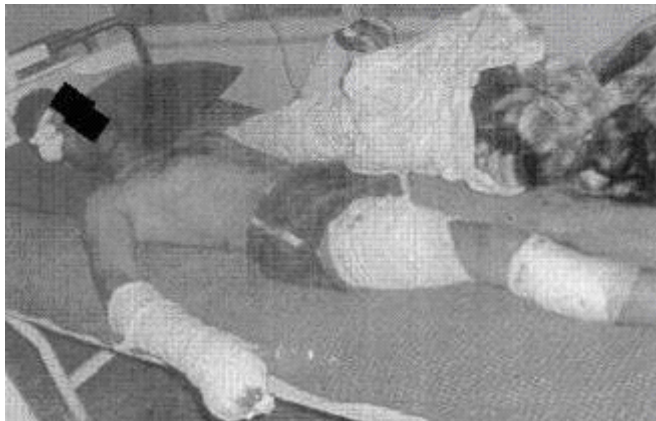
The Victim's injuries were listed in the Internal demining group investigation as:

"Three Fragmentation wounds to forehead. One of these wounds has forced his right eye to close. although the doctors are confident that no foreign bodies entered the eye and that this is just associated swelling

"Deep laceration to left bicep (approx. 3cm deep). No arterial damage.

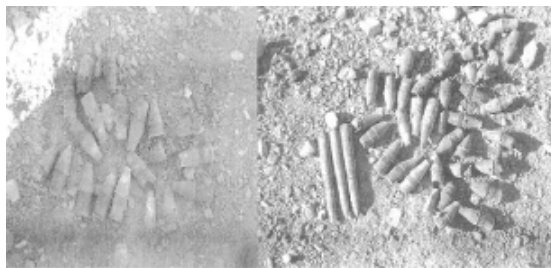
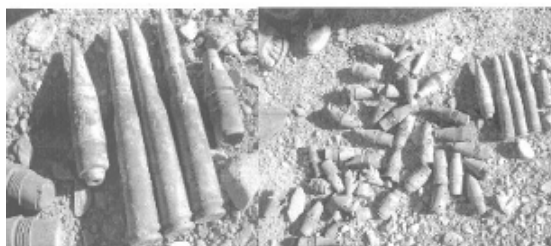
These UXOs kicked out on 08 March 2006 during [International demining group] Demolitions.
