# DDAS Accident Report

REPORT OF BOARD OF INQUIRY INTO DEMINING ACCIDENT AT KIRGOCHAK ON 27  
JUNE 2007

Dushanbe 04 July 2007

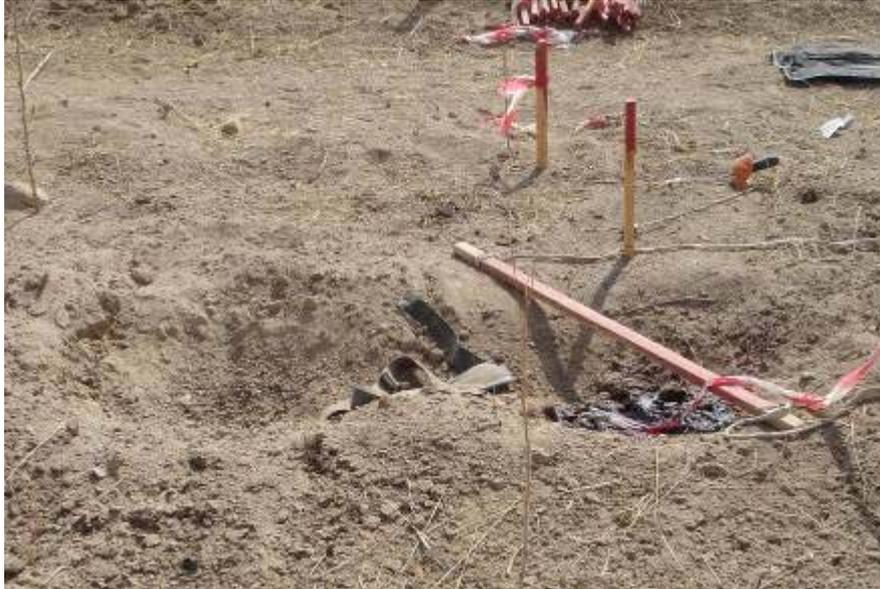
Accident site, [showing marking placed after the accident.]

Although the minefield is well marked, it was noted during the Board of Inquiry's investigations at the site, that the mine clearance site was not well marked. In particular, it was observed that insufficient marker pickets and marking tape had been deployed to show the line between cleared and uncleared areas. The area where [the Victim] was working was clearly the most potentially dangerous area on this part of the minefield, because he had a line of uncleared mines to his left, a line of craters created by recently destroyed mines to his right and a similar line behind him. In front of him there was a point where the line of craters stopped and continued as a line of uncleared, undiscovered mines. Despite this, there was no significant difference in marking here than at any other place on the minefield and marking to show where the line of cleared mines ended and where the uncleared area started was minimal.

12. Marking between cleared and uncleared areas should be improved. This is particularly important in areas where long lines of antipersonnel mines are being cleared by hand and multiple detonations of mines has occurred; it is difficult for deminers to see exactly where the end of the demolitions shot(s) finish and the uncleared mines lay. Demolitions supervisors should be fully aware of exactly how many detonations have occurred after every shot and how many detonators or charges have failed. The only way to be quite certain of this is to physically visit each crater to inspect whether the charge detonated as planned; therefore demolitions supervisors should count craters immediately after any demolitions task is completed and mark the end point of the tasking. In the case of Kirgochak minefield, where there is almost no vegetation and the mine rows are only a few metres from the barbed wire perimeter fence, this procedure can be carried out easily and without entering the dangerous or uncleared area.

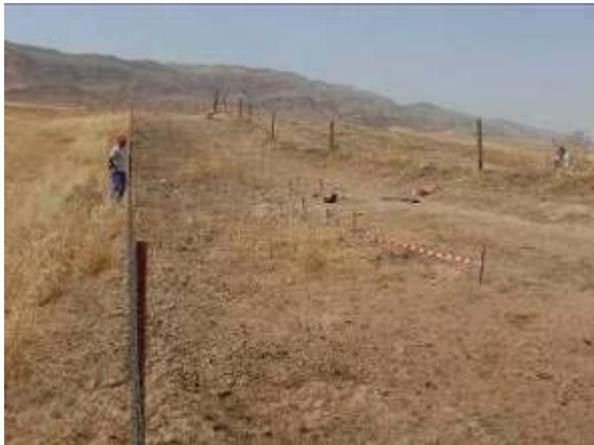
Perimeter Minefield Around an Ammunition Depot

The minefield is situated within a strip of ground, approximately ten metres wide and lined on each side by ten strands of barbed wire fence, suspended on angle-iron pickets, which are spaced at ten metre intervals around the minefield. It consists of three rows, each about two metres apart, of PMN antipersonnel landmines. Mines are spaced approximately 50cm to one metre apart, and the rows continue all around the entire perimeter of the ammunition storage depot.

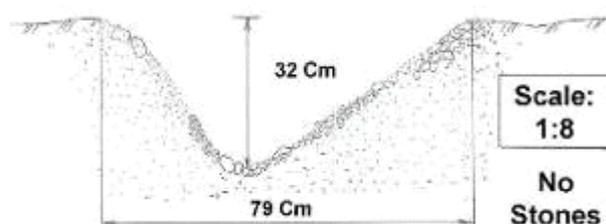
Analysis of the craters caused by the detonations shows that both of the mines involved in this accident were buried at a depth of approximately 12 centimetres in the ground and less than one metre apart. All PMN mines found by [Demining group] at Kirgochak so far have been buried at depths of less than 15 centimetres. Further evidence that mines at this task site are laid in shallow excavations may be deduced from the many uncleared mines which can be seen protruding from the surface of the ground. The mines were laid in the middle row of three rows. Mines were originally laid at this site by Russian armed forces in C1973 and the location was handed over to Tajikistan's Border Force in 2005.

Crater A [the crater he stepped in.]

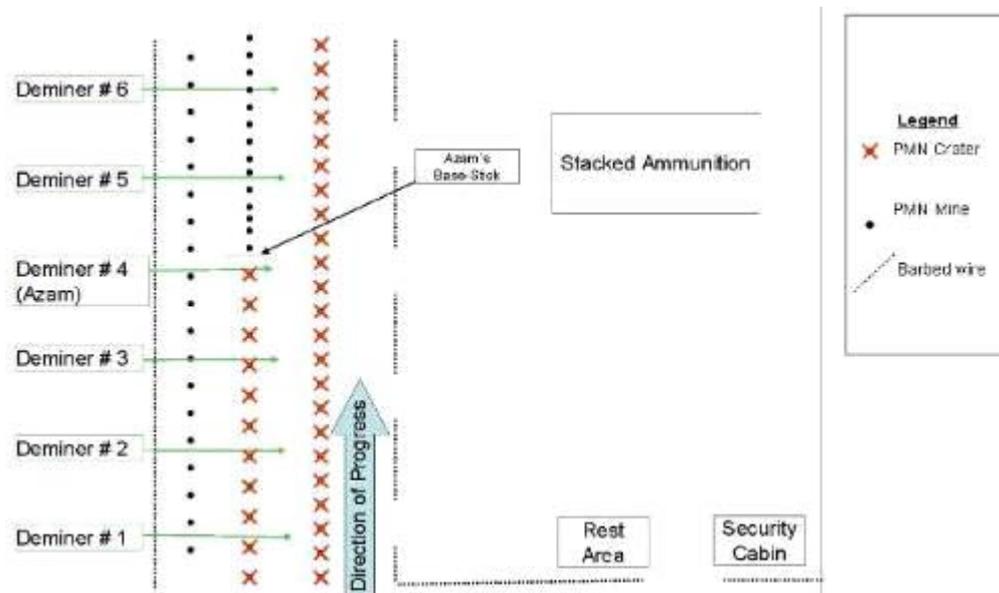
Each deminer was separated from his nearest co-worker by a distance of approximately twenty-five metres, as shown in the diagram below. Each deminer was responsible for the clearance of the ground between his own position and the position where the next deminer was working in front of him.

[The Victim] deployed to the middle part of this line of workers, with three deminers in front of him, each spaced at twenty-five metre intervals apart from the next, and three deminers behind him at similar spacing.

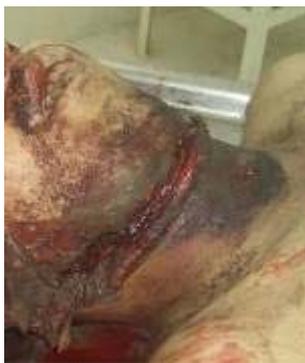
Throat injury

Loss of left foot; extensive damage to leg up to genital area; loss of testes; minor damage to right leg; blast injury to inner left forearm; blast burns to chest; partial decapitation including severing of both arteries.

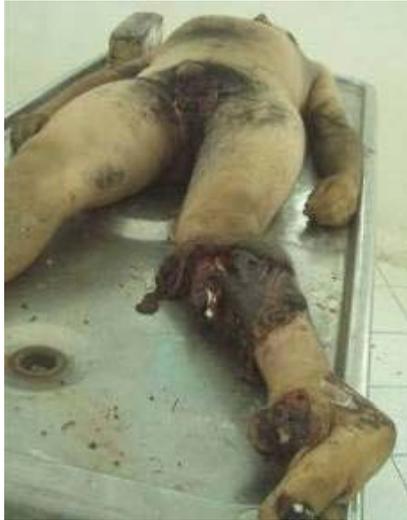
All lower body injuries.

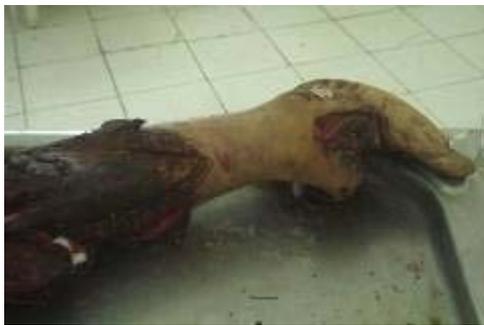
Remains of foot

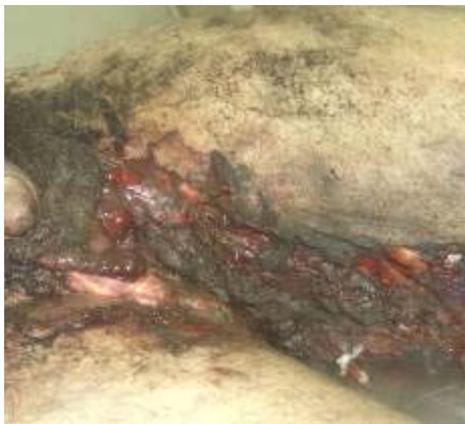
Upper inner thigh and genital injury.

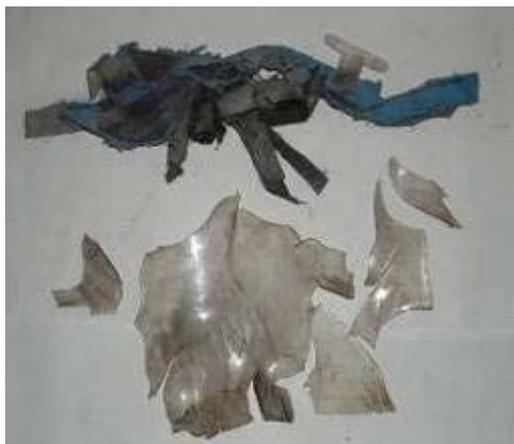
**Visor.** [The Victim]'s visor is severely deformed, broken and damaged by heat and blast. See images at Annex N [not included]. Close inspection of the largest piece of visor recovered after the accident showed enough side edges to determine its orientation. It is the lower part of the visor with the top edge entirely removed. The polycarbonate material was heat distorted, rippled and bubbled. It had been extensively thinned by stretching (from an original thickness of 5mm to 2mm) and heated to well above its forming temperature (at least 180 degrees Centigrade) throughout its thickness. A bottom corner had split and twisted inward, forming a sharp shard approximately 5cm long that pointed in towards the wearer's throat. The visor head-frame, made of ballistic aramid with a washable cover, had been shredded at the front. Visor damage is consistent with it receiving an extreme shattering force near the top centre and an extreme temperature for a microsecond. Fragments of the dark blue ballistic-aramid material used in the manufacture of the visor's head-frame were later found in the crater, (along with a small piece of burnt Bakelite, originally from the outer casing of the PMN mine and the remains of its striker-pin and spring).

The bottom of the visor is closest to the camera, heat bubbling and distortion is evident. The top of the visor is missing. Fragments of the head-frame material were found in the second crater.

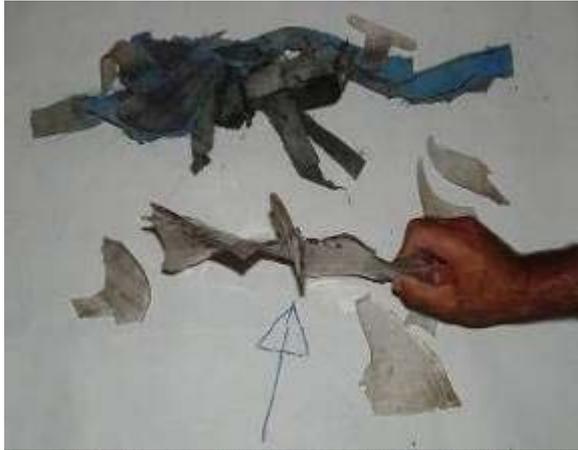
It seems probable that a mine was initiated by the wearer falling forward and striking the ground above a mine with the top part of the visor. The damage to the victim's throat is consistent with the sharp shard of visor on the lower edge being torn sideways as the visor was thrown away by the expanding blast wave.

Twisted spike at bottom of visor which injured the Victim's throat as it was torn aside.

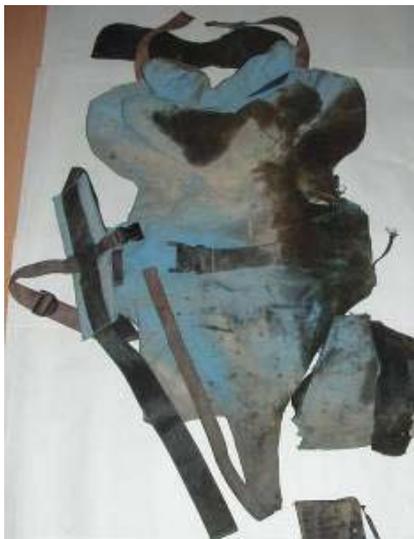
On inspecting the body armour, the damage was found to be concentrated on the left side, with panels torn away. This is consistent with the victim having stepped with his left foot on a mine while leaning forward. The front of the victim's left boot was missing and his shin (above if leaning forward) had been shattered. When reconstructing this position, the groin and genitals are directly above the seat of initiation and so inside the fragment cone associated with the detonation of a buried mine. The groin injuries are taken to confirm the victim's position.

What is inconsistent with the left-side frontal damage to the armour apron is the fact that the apron straps were torn from the apron (breaking nylon stitching), plastic buckles had snapped, and the apron was thrown 12 metres from the victim's body. The inner armour panel of the throat protection was also thrown aside, although its Velcro-fastened cover was undamaged. In the absence of other explanations it seems likely that the straps were broken and the collar emptied by a blast from above that entered behind the armour and sought to expand between the body and the armour, forcing the armour to break at its weakest points. When it broke, pressure behind it had built to the point that the armour was thrown aside and landed a distance away. A blast from above the armour neck-hole is consistent with the visor damage.

The Victim's PPE showing blast damage down the left side and straps torn off.

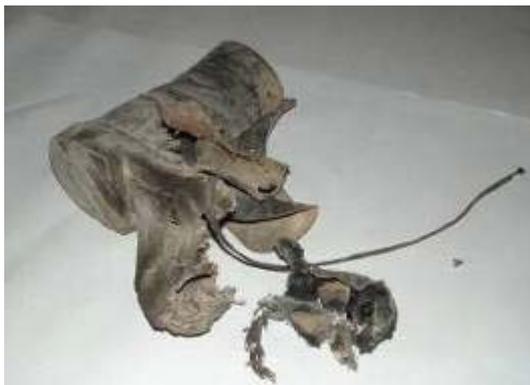
The victim's left boot.
