# DDAS Accident Report

<b>Report date:</b> 15/01/2008	<b>Accident number:</b> 475
<b>Accident time:</b> 06:55	<b>Accident Date:</b> 26/08/2006
<b>Where it occurred:</b> MF No. 004, North South Sector, Beyr Mathkour, Wadi Araba	<b>Country:</b> Jordan
<b>Primary cause:</b> Field control inadequacy (?)	<b>Secondary cause:</b> Inadequate training (?)
<b>Class:</b> Excavation accident	<b>Date of main report:</b> 28/08/2006
<b>ID original source:</b> NS-10-05/26/08/06	<b>Name of source:</b> JES
<b>Organisation:</b> [Name removed]	
<b>Mine/device:</b> No 10 AP blast	<b>Ground condition:</b> dry/dusty hard sandy
<b>Date record created:</b> 15/01/2008	<b>Date last modified:</b> 15/01/2008
<b>No of victims:</b> 1	<b>No of documents:</b> 2

## **INDEPENDENT INVESTIGATION REPORT**

OF MINE INCIDENT AT BEYR MATHKOUR

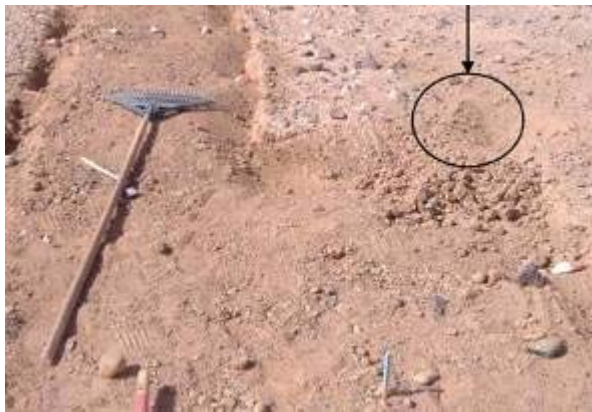
The crater depth was approx. 18cm and its width approx 45cm.

[The position of the accident is circled below.]

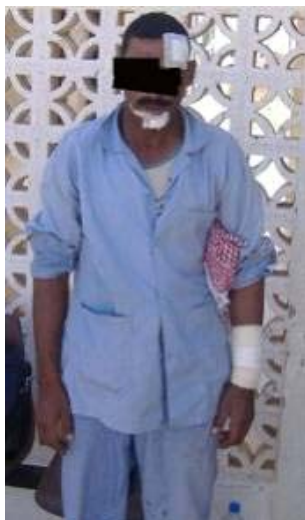
"Three superficial wounds left lower arm, left femur, left side of his forehead and left side of his chin.

Pictures below show very light injuries.
