# DDAS Accident Report

## **INCIDENT REPORT**

MINEFIELD TASK ID - NS - 10 - 16

TYPE OF MINE: NO-10 ISRAELI ANTI PERS MINE

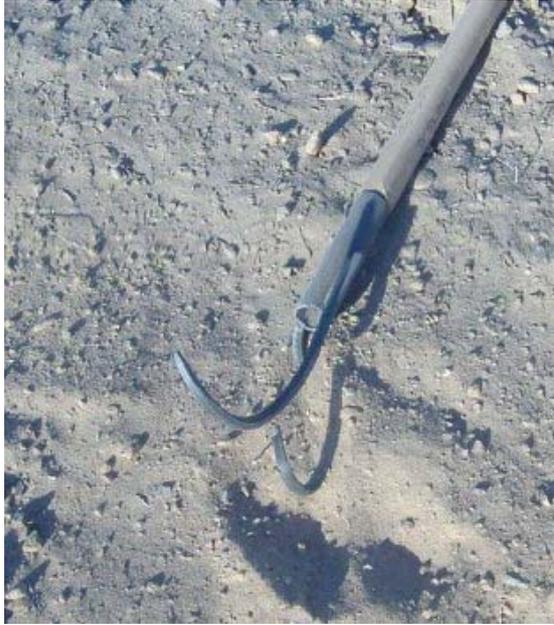
A [Demining group] Manual Team One, deminer hit a No.10 AP mine from the top that resulted in a mine blast. The deminer suffered no injuries. He was wearing his protective Vest and Goggles. [Photographs of both Victim and PPE showed no damage.] The tines of the heavy rake were bent.

The primary cause of this accident is listed as a "Field control inadequacy" because the photographs show that the initiation occurred outside the lane (marking is achieved by side of lane trenches) on ground that had not been "brushed" with the Light rake. In the correct procedure, the Light rake is used before the Heavy rake. It seems that Victim was working in a manner that conflicted with authorised procedures and his mistake was not corrected. The secondary cause is listed as "Unavoidable" because there is not enough information in the report to be certain of the cause, and the deminer may not have been at fault.

The demining group had put in place the use of a long tool (rake) that kept the Victim far enough away from a blast to avoid serious injury, but the raking process that this demining group has pioneered is only safe if systematically conducted in a disciplined manner. As with any tool, rakes can be misused. The most common misuse is "Hacking" at hard ground with the Heavy rakes, which this man apparently did. The distance still provided some protection and probably prevented injury.

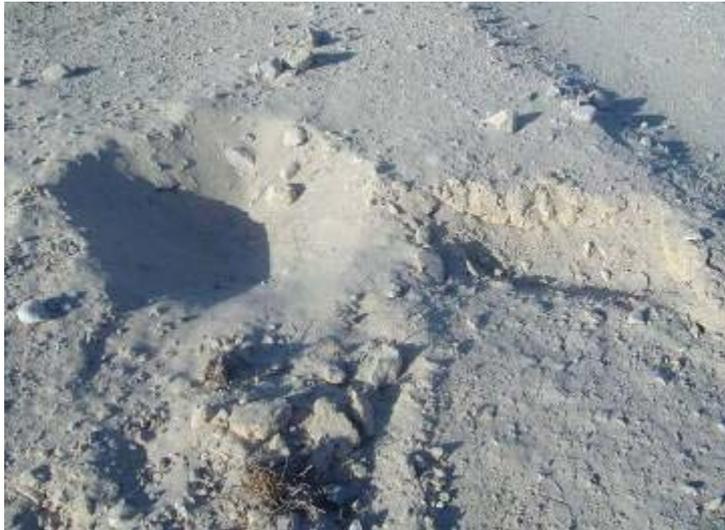
The crater left by the initiation was approx 15cm deep and 30cm wide.
