DDAS Accident Report

INCIDENT REPORT

ISRAELI MINEFIELD NO - 003

MINEFIELD TASK ID - S 67

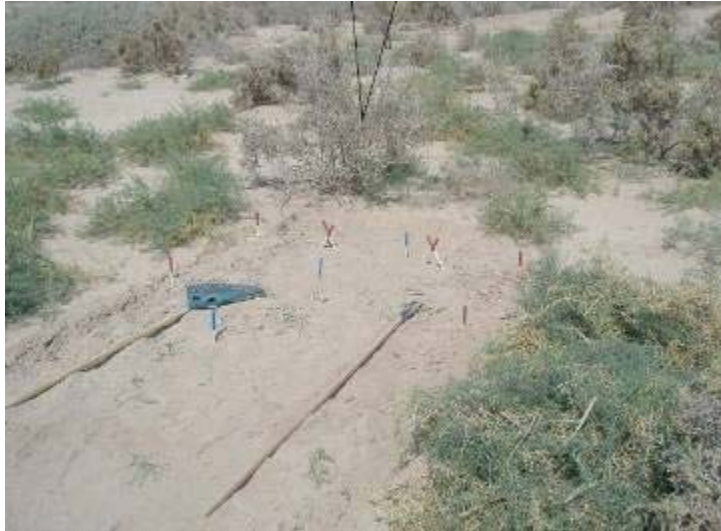
The crater left by the blast was approximately 15cm deep and 30cm wide.

The ground at the accident site was described as hard and mixed. The weather at the time was clear and hot. The vegetation was described as heavy bush. [“Heavy bush” in a desert environment may not be the same as in more temperate areas: see the photograph of the site below.]

[The blue topped pegs indicate where mines were found. The peg just in front of the crossed red-topped sticks is the seat of initiation.]
