# DDAS Accident Report

## BOARD OF INQUIRY INTO DEMINING ACCIDENT

AT KIRGOCHAK ON 13 NOVEMBER 2007

Dushanbe, 20 November 2007

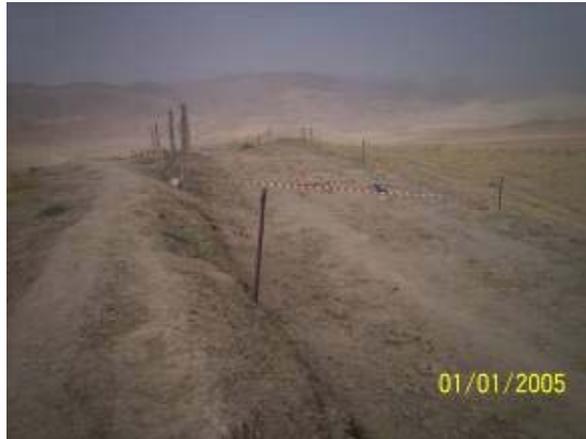
8. The general area where the accident occurred is grassy pastureland, wheat fields and rolling hills. The point of detonation was on an area of ground on a slight incline, at the distance of 13 m. from the minefield. [The picture below shows the general area.]

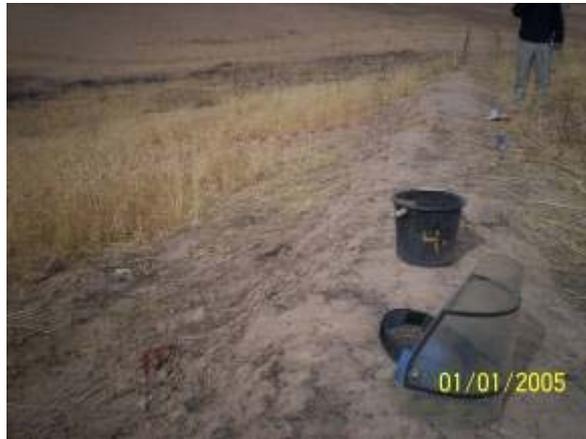
[The picture above shows the accident site.]
