DDAS Accident Report

LESSONS LEARNED SUMMARY

DEMINE ACCIDENT ON DEMINER OF [International demining NGO] AT BAGRAM

DATED 04 JUNE 2007

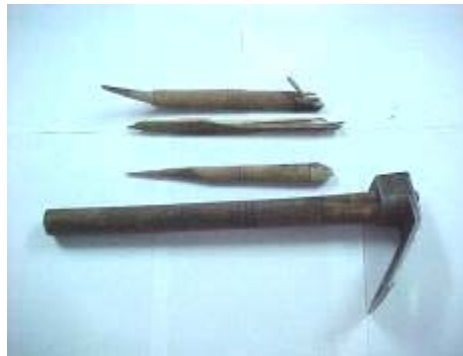
The trowel used by this International demining NGO may have been a short “mattock”, which they often call a “trowel” without explanation. Their mattock has featured in many accidents because it is difficult to use without considerable force. Its use is fast, but makes initiation more likely, as detailed in the GICHD Manual Demining Study 2005. From records in this database it can be seen that the mattock has caused severe injury when the head breaks off

and strikes the user. The deminer's arm loss in this accident may be a case in point. An example used by this International NGO in another country is shown below.
