DDAS Accident Report

| Report date: 18/01/2008 | Accident number: 485 |

Demining Investigation Report

DEMINING ACCIDENT ON DEMINER OF [International demining NGO] AT KOH-E-SAFI

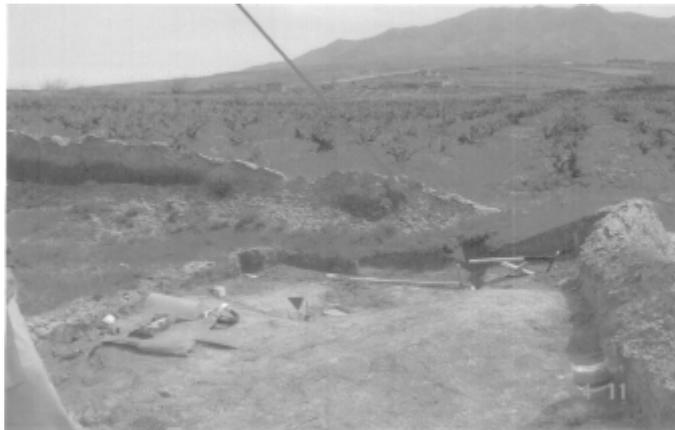
[The accident site, showing the mud-brick wall that has collapsed at the accident place.]

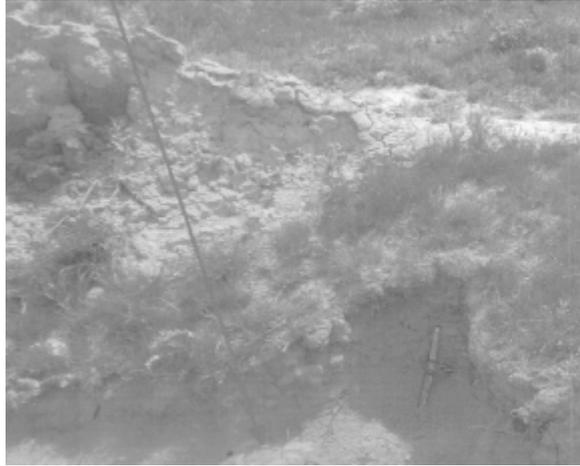
3. The accident has occurred near corner of a ruined mud wall, the mud of the wall has gradually huddled on the ground surface as its height reached to 40 cm at the accident point, the deminer has failed to firstly remove this soil from original surface of the ground then consider the 15 cm depth from original surface of this area.

[The picture below shows the accident site and the depth of the collapsed wall.]

a) The accident has happened near the corner of a ruined muddy wall as because of timeworn, wetness the mud gradually poured down and reached to 40 cm at the accident point. The deminer has failed to firstly remove this soil and then address the original surface of the ground with 15 cm depth.

1. Whenever the deminers are working on an area on which sediment soils have been gathered, they must firstly remove the sediment soils from the original ground surface then consider 15 cm depth.

a) Whenever deminers work in areas, on which sediment soil exist, they must firstly remove the extra soil systematically and safely in layers and after the original surface is appeared then 15 cm depth to be considered.

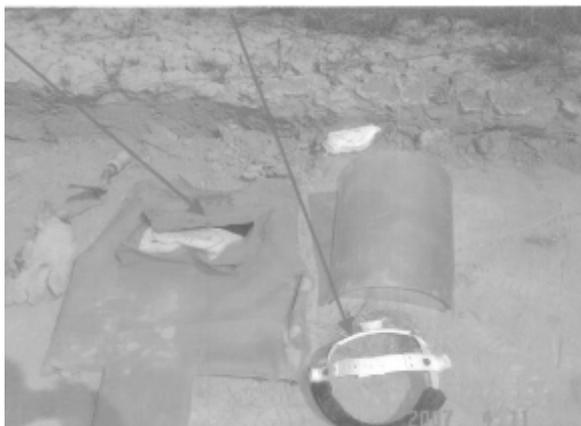
Description of damage to property: 1. Visor belt has been disconnected from the visor; 2. Cover of the PPE vest was torn.

[The torn cover of the PPE vest and broken plastic head-frame of the visor. The trowel is top left. It is a large plasterer's trowel, mild steel with wooden handle. The photograph is unclear, but it seems to be broken.]

The builder's trowel used by this Victim is not a safe tool, breaking all of the design requirements for a blast resistant tool.
