DDAS Accident Report

Report date: 21/01/2008	Accident number: 489
Accident time: 09:15	Accident Date: 14/10/2006
Where it occurred: Task # H/1397, Durani Village, Koh-i-Safi District, Parwan Province	Country: Afghanistan
Primary cause: Field control inadequacy (?)	Secondary cause: Inadequate equipment (?)
Class: Excavation accident	Date of main report: 16/11/2006
ID original source: OPS/27/435-06	Name of source: UNMACA
Organisation: [Name removed]	
Mine/device: PMN-2 AP blast	Ground condition: bushes/scrub soft
Date record created:	Date last modified: 21/01/2008
No of victims: 1	No of documents: 2

Subject: REVIEW OF BOARD OF INQUIRY CA-87

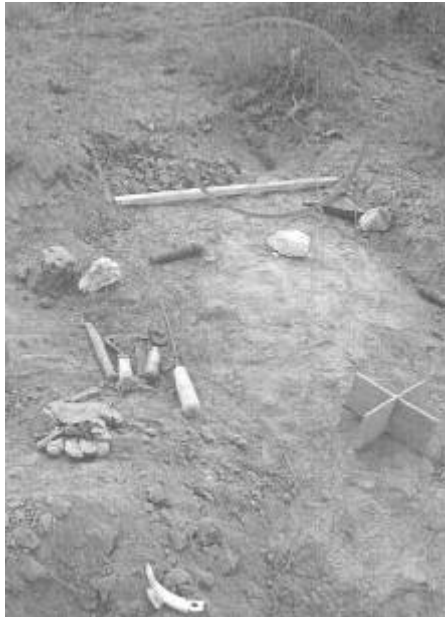
Evidence of a detonated UXO (or possibly a booby-trapped munition) was found in and surrounding the blast crater at the base of the explosion. [No evidence of this was shown. The accident site is shown below.]

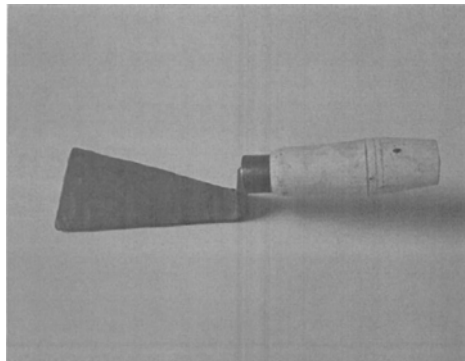
Also, that the excavation tool that the deminer was using was inappropriate and dangerous and that it should be withdrawn from issue and replaced immediately.

The Secondary cause of this accident is listed as “inadequate equipment” because the hand-tool in use was not designed for purpose, was not made using appropriate materials, and was recognised by the investigators and the International demining NGO as having contributed to injury.

An alternative excavation tool will be sourced and trialled in the central region to assess whether its design would be more suitable for excavation than the current 'chipping' trowel. [Shown below.]

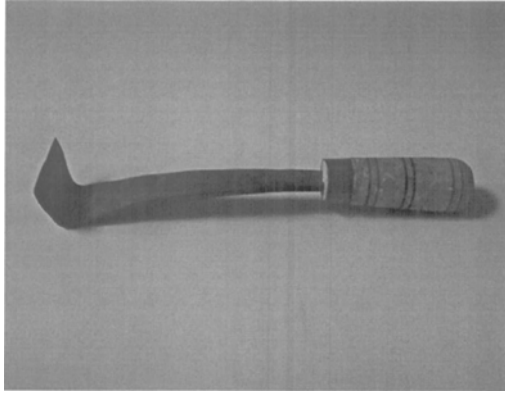
The tool to be trialled in the Central Region is shown below.

Both causes are ultimately “Management control inadequacies” because the demining group’s managers only recognised them after the event. Their proposed replacement hand-tool has all the inappropriate design features of the tool it will replace, and represents a significant failure to learn from experience.

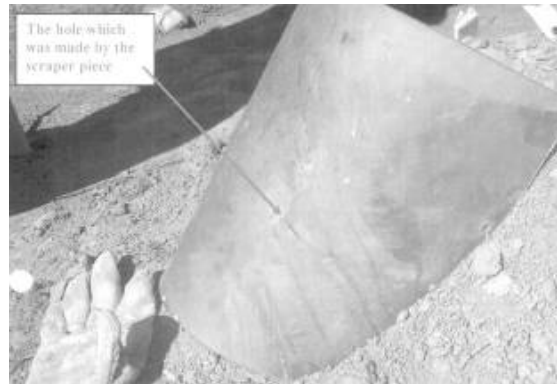
The visor is shown below, pictures reproduced from the International Demining NGO's internal report.

“Visor – Deminer accidentally detonated mine while excavating. Excavation tool was propelled directly at visor, causing a crack and penetrating visor. The blade of the tool and/or the crack of visor impacted the deminer’s head causing a deep wound to the forehead that proved fatal.”

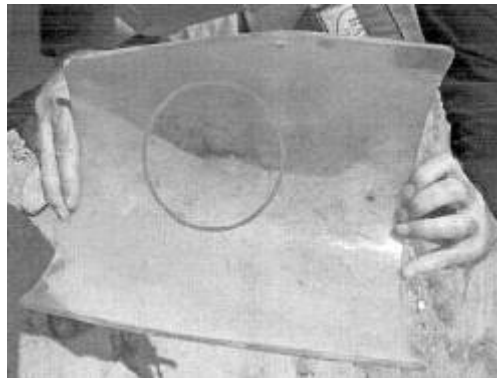
Deminer's visor — reverse ("crack" from tool circled below)

The damage is below the middle of the visor. The forehead of anyone wearing the visor correctly would have been at least 5cm higher. The Visor head-frame was shattered in the event. The brittle plastic head-frame of this design of visor frequently breaks in a blast event but rarely shatters. Its destruction may imply that it was being worn with the visor raised so the visor's position at the time of the accident cannot be known with certainty.
