DDAS Accident Report

Subject: Investigation Reports & Lessons Learned from the Demining Accident Happened on [International demining NGO] Loader at Goor-Dara village, Khwaia-Ghar district of Takhar province on 19 April 2007

DEMINING ACCIDENT HAPPENED AT [International demining NGO] LOADER AT GOOR-DARA ROAD, HAMWARSAI DISTRICT OF KHWAJA-GHAR DISTRICT ON 19th APRIL 2007

Investigation Report of Mine/UXO Accident/Incident within the Ground of Demining.

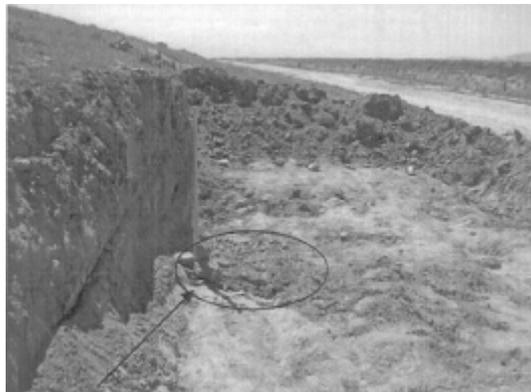
[The accident site is shown below.]

A. On 19 April 2007, while the [International demining NGO] loader (MDU # 9) was excavating the ground by using Gill bucket and then the soil inspecting for Antitank mines and UXO but an antipersonnel YM-1 mine has passed through the grids of the Gill bucket and missed from inspection. While the Loader has been levelling the loose dragged soil, in reverse position the front left was tyre driven on the mine and exploded it.

The accident did not have any casualty but small damage on the rubber of the tyre.

The mentioned incident has happened when the MDU-09 was levelling the loose/ excavated soil after the clearance process. The loader was excavating the ground by its bucket then by its gill system the soil was inspecting for AT mines and large UXO. During the inspection process an AP mine type YM-I was passed through the grids of bucket, and missed to be inspected. While the loader was levelling and dragging the loosed soil in reverse position its front left side tire stepped on the mine and was exploded. It haven't caused any serious damages to the machine only the robber portion of tire got some damages, fortunately didn't cause casualty as well. As soon as the accident had happened the team's operation was ceased, and the movement of the machine was stopped to avoid further accidents/ incidents and to conduct the investigation. The report was relayed to [International demining NGO] Operation section and to the AMAC Kunduz by [International demining NGO] Operation officer.

The star basket system with MDU should be used for the rest of the task: as the APMs and small UXO to be inspected thoroughly which are not able dropping through the grids of this system while in the Gill system it has the possibility of dropping due to the wider holes.

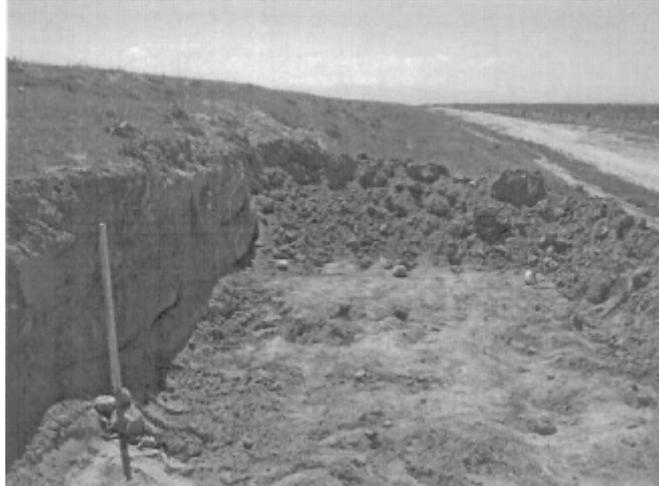
Site conditions: The ground was described as flat and open. The soil was soft and dry. The weather was clear and mild. There was no vegetation.

Depth of the mine from the hillside 1m.
