DDAS Accident Report

Report date: 21/01/2008	Accident number: 491
Accident time: 09:40	Accident Date: 18/08/2006
Where it occurred: Durrani Village, Koh-e-Safi District, Parwan Province	Country: Afghanistan
Primary cause: Field control inadequacy (?)	Secondary cause: Victim inattention (?)
Class: Excavation accident	Date of main report: 03/10/2006
ID original source: none	Name of source: UNMACA
Organisation: [Name removed]	Ground condition: dry/dusty
Mine/device: PMN-2 AP blast	Date last modified: 21/01/2008
Date record created:	No of documents: 1
No of victims: 1

DEMING ACCIDENT REPORT

DURRANI VILLAGE, KOH-E-SAFI, Parwan Province. Task No.H/1397

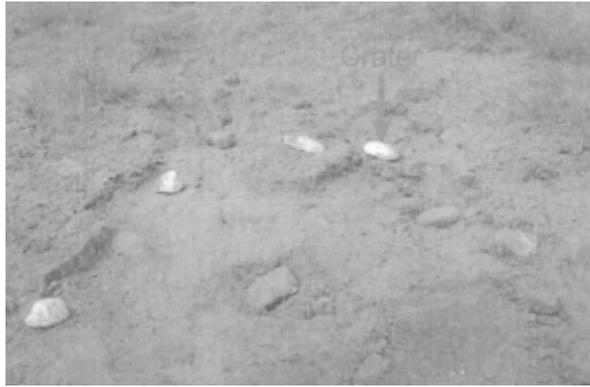
The deminer stated that he started demining work at 0600 at the morning; he was not medically or physically unfit. Before 0940 he had found two PMN2, which were destroyed by the team leader - marked by the two further green stones in the photo (below). At 0935 he found a signal with his detector, approximately 40 cm to the right of the previous mine. He proceeded to excavate towards the signal, adopting a squatting position and holding his detector in his left hand. He admitted that he had not placed an isolation marker before he started excavating.

The deminer stated that the two mines that he had found earlier that day had only been 5cm deep, and that he did not expect to find another mine so close to the last one [even though the previous three had been with 2 metres of each other], or so deep; he therefore assumed that the signal was not a mine. He thinks that the mine was deeper than 10cm below the surface. He accepts that he may have exerted too much pressure whilst excavating.

It appears that the deminer started excavating at a depth of 10cm below the surface at his end-of-lane marker, instead of starting 10cm below the signal; and that he was therefore excavating down the slope instead of horizontally. It is not possible to tell whether he started his excavation the full 15cm back from the signal; given that he did not use an isolation marker it may be that he did not. However it is clear from other excavations further back in the same lane that the deminer had not always maintained the correct 10cm depth.

The Regional Operations Officer (Central) will ensure that all supervisors explain to all team leaders the importance of excavating at the correct depth and in the correct direction, and that team leaders pass this on to their teams.

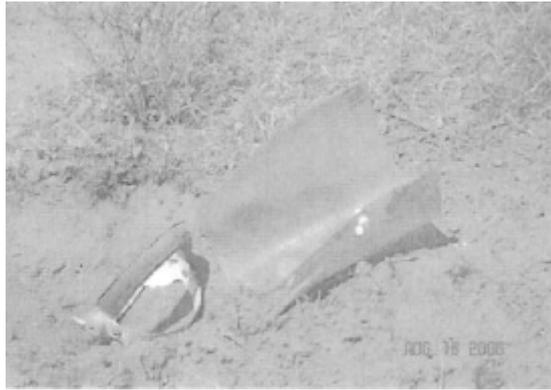
From the condition of the visor and PPE, it appears that the deminer was wearing his PPE correctly. [The visor, broken from its plastic head-frame, is shown below.]

The deminer was saved from serious injury by the fact that he was wearing PPE correctly; and possibly also by the shape of the ground.
