# DDAS Accident Report

<b>Report date:</b> 22/01/2008	<b>Accident number:</b> 498
<b>Accident time:</b> 06:00	<b>Accident Date:</b> 09/06/2006
<b>Where it occurred:</b> Task # 084, Abdiby Village, Charikar District, Parwan Province	<b>Country:</b> Afghanistan
<b>Primary cause:</b> Field control inadequacy (?)	<b>Secondary cause:</b> Inadequate equipment (?)
<b>Class:</b> Excavation accident	<b>Date of main report:</b> 30/07/2006
<b>ID original source:</b> OPS-271354-06	<b>Name of source:</b> UNMACA
<b>Organisation:</b> [Name removed]	
<b>Mine/device:</b> PMN-2 AP blast	<b>Ground condition:</b> building rubble dry/dusty hard rocks/stones
<b>Date record created:</b>	<b>Date last modified:</b> 22/01/2008
<b>No of victims:</b> 1	<b>No of documents:</b> 2

Subject: Investigation Report

## IMSMA Demining Investigation Report

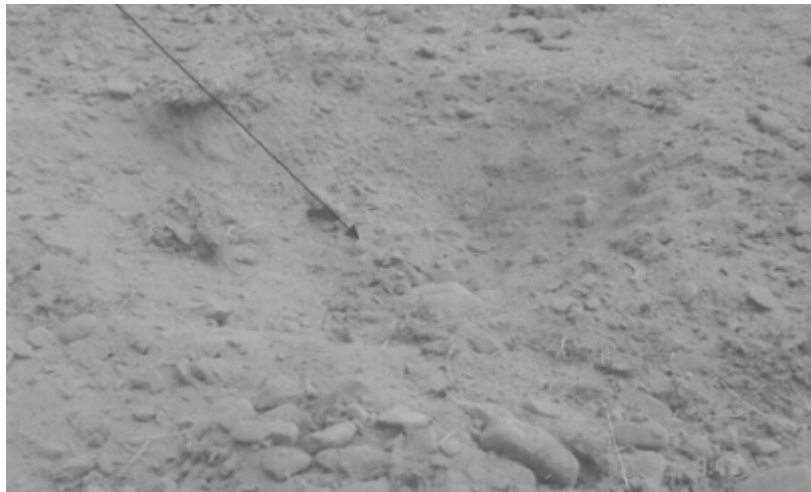
[The accident crater is shown below.]

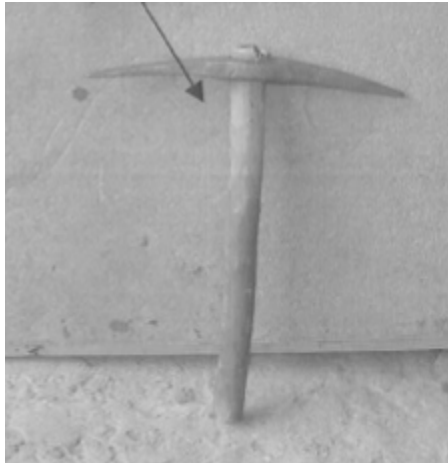
[An example of the pick that the team uses in the site.]

4. The team command group should ensure that the deminers are excavating the signals with appropriate hand tool.
5. When the team is working in a site in which they do not find any mine for a long time the teams should not be confident that there is no mine in the task at all.
