DDAS Accident Report

Subject: Missed Mine Investigation Report

Accusatory details if mine is missed: MF.No. AF/0308/01648/092.

Device caused the incident/accident: YM-1 AP blast mine

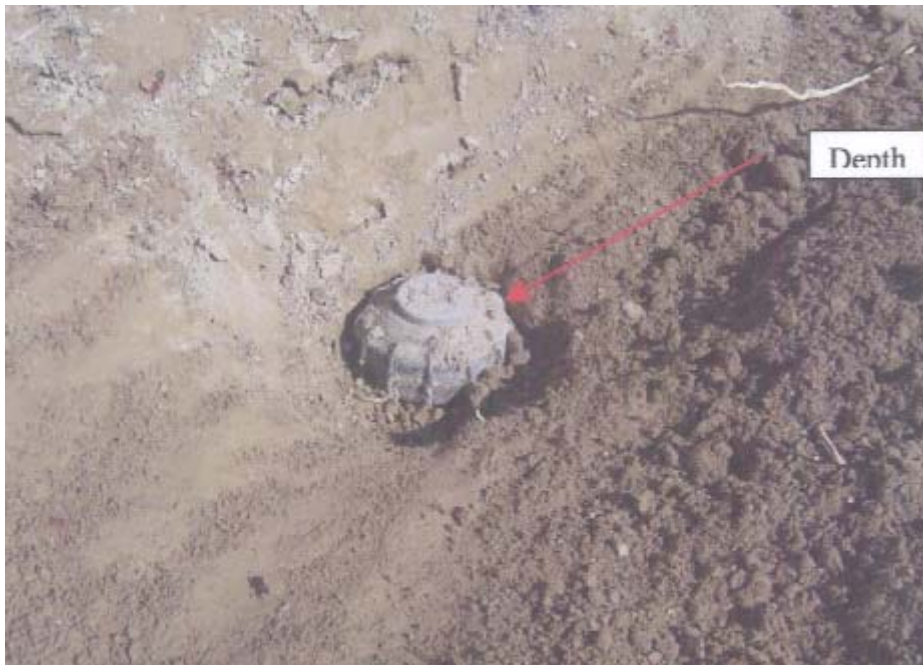
THE MINE

The mine had not blasted and the local resident found it during excavation in his house yard. While the house owner was excavating land by shovel, the AP mine was discovered.

2. As the type of the discovered missed mine is YM-1 which contains minimum metal, there is the possibility of other similar type mines in the above-mentioned site.

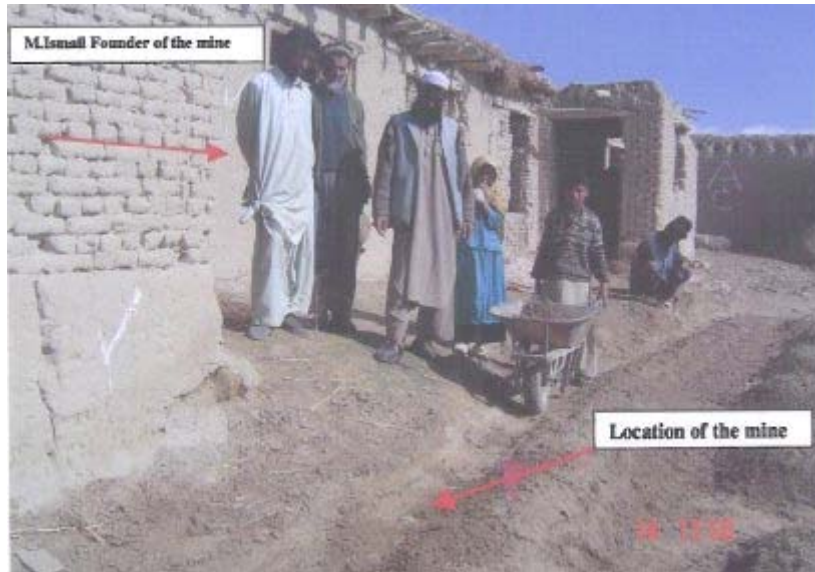
THE PLACE WHERE THE MISSED MINE WAS FOUND

1. As the house is a ruined house, the presence of the extra soil on the surface of the ground was visible and it seemed that those soils were not excavated, removed and checked properly and in accordance with the requirements of the SOP and task order.

3. According to the observation of the investigation team the inner side of the house-surrounding walls with five meters width seemed as un-checked. The original undisturbed ground surface has not been considered during the clearance operation. Although it was clearly mentioned in task order that the task should be cleared/checked to the depth of 13 cm from the original undisturbed ground level. The discovered mine was also, located in this 5-meter width.

1. It is recommended that the inner side of the house walls with five meters width should be rechecked with the depth of 13 Cm from original undisturbed ground surface.
2. The clearance teams should consider the depth of 13 Cm from the original surface of the ground not from the top of the extra soils.
3. Prior to handing over of the task, the clearance team should collect all the red marks and other signs of the cleared area and mark the cleared area by the white paint properly till the cleared area and unclear area be differentiated easily. We suggest that the area in which the house owner is not sure is estimated about 600 m2 to be rechecked and cleared with 13 cm depth from original surface level of the ground.
