# DDAS Accident Report

<b>Report date:</b> 25/01/2008	<b>Accident number:</b> 509
<b>Accident time:</b> 09:10	<b>Accident Date:</b> 18/01/2007
<b>Where it occurred:</b> MF # AF/3208108364/MF01 1, Dwa-Mandy Village, Nadersh-Kot District, Khost Province	<b>Country:</b> Afghanistan
<b>Primary cause:</b> Field control inadequacy (?)	<b>Secondary cause:</b> Victim inattention (?)
<b>Class:</b> Detection accident	<b>Date of main report:</b> 24/01/2007
<b>ID original source:</b> OPS/2/2/21-014-07	<b>Name of source:</b> UNMACA
<b>Organisation:</b> [Name removed]	
<b>Mine/device:</b> PMN AP blast	<b>Ground condition:</b> dry/dusty rocks/stones
<b>Date record created:</b>	<b>Date last modified:</b> 25/01/2008
<b>No of victims:</b> 1	<b>No of documents:</b> 2

Subject: Demining Accident Investigation Report of [National demining agency] MCT#1

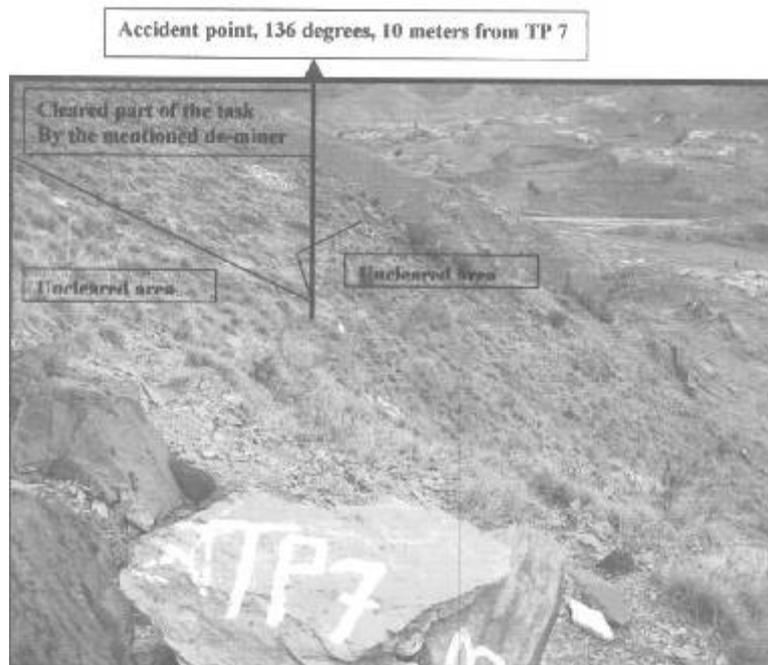
Device was detonated in area where it was difficult to be clear from the right to left, due to sloppy [sloping] condition.

The area of ground being cleared was sloping and the deminer was clearing 1 meter across the slope before proceeding up the slope a further 5 meters.

The accident site

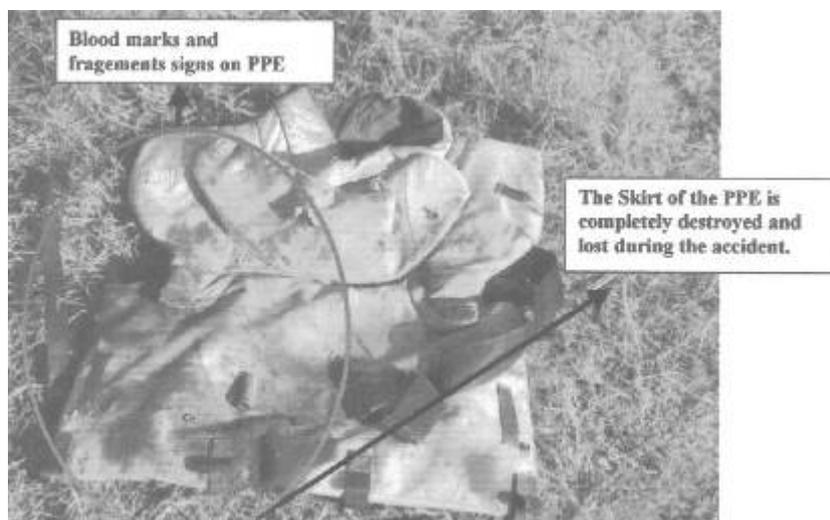
Equipment/property damage: Metal detector (MLD-1); Frag-vest; Helmet, visor. [The apron style vest is shown below.]

The lower part of the PPE was "lost", raising questions over whether the PPE design offers adequate protection to the body when stepping on a mine. The visor snapped at its fixing point, (shown below) which is a common failing of this type of helmet-mounted visor.

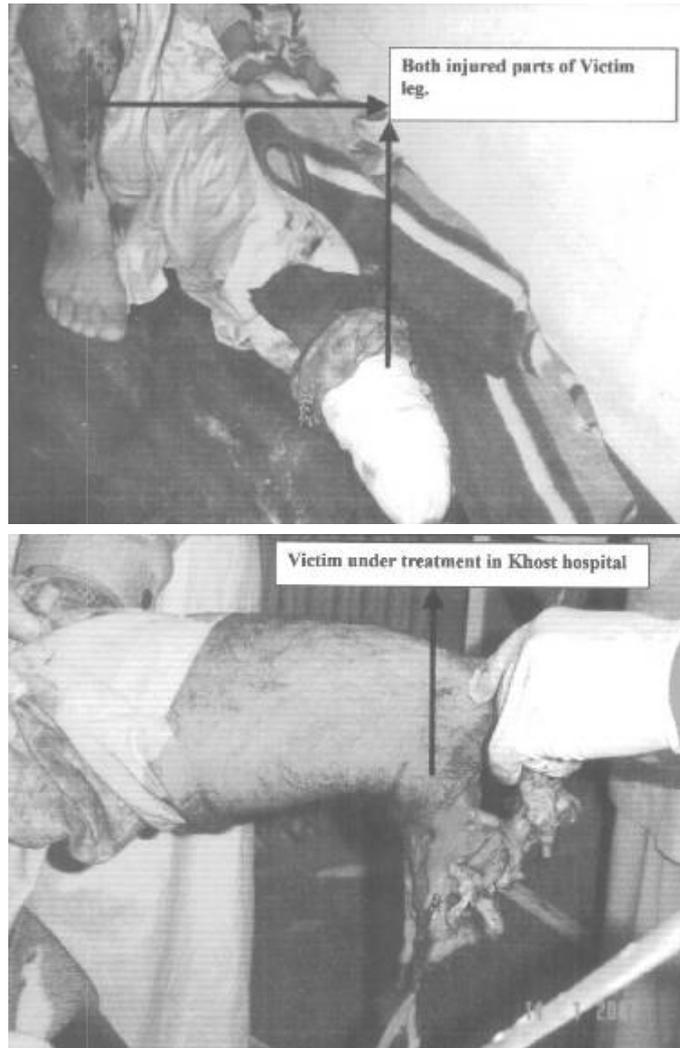
The IMSMA sketch showed loss of left foot, other injuries to upper limbs and lower limbs.

Left foot amputation. Right arm injury. Right knee joint injury.
