# DDAS Accident Report

DEMINING ACCIDENT (February 19, 2007)

Sub: MINE INCIDENT INVESTIGATION REPORT

### **Investigation report of Mine/UXO accident/incident with the ground of demining**

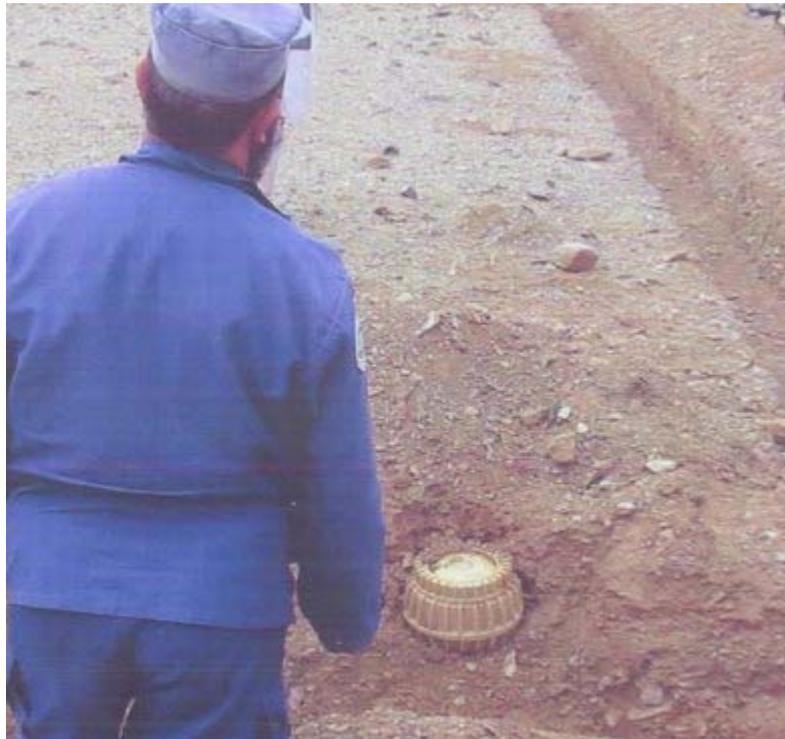
As the mine was already removed and destroyed by [National demining agency] EOD team in the area tasked by UNAMAC, the investigation team only observed the mine site, its photograph in its original cradle/frame and it shows that the mine was in normal position/depth not more than 10 cm.

[The photograph taken by the EOD team.]

The TC/6 mine is difficult to detect with a metal detector. It was buried at ten centimetres to the top of the mine in friable earth. It is "difficult to detect" with a metal detector. It has a steel ball, spring and firing pin but these are "non-magnetic" which reduces their signal with most metal-detectors. To be certain of locating them reliably in any particular soil, real targets (rendered safe) should be buried and the detector used to confirm that a signal is received.

The use of well trained MDD should have ensured detection of a mine with a 6 kg High explosive content of Composition B (TNT/RDX) buried at 10cm in what appears to be friable soil for several years.
