DDAS Accident Report

INVESTIGATION REPORT INTO MINE ACCIDENT

WHICH OCCURRED ON 04th MARCH 2004 AT M4101 MINEFIELD, O'Chrey Village, Kamreing Commune, Kamreing District, Battambang PROVINCE

REPORT PREPARED BY: DEPUTY DIRECTOR, PLANNING AND OPERATIONS

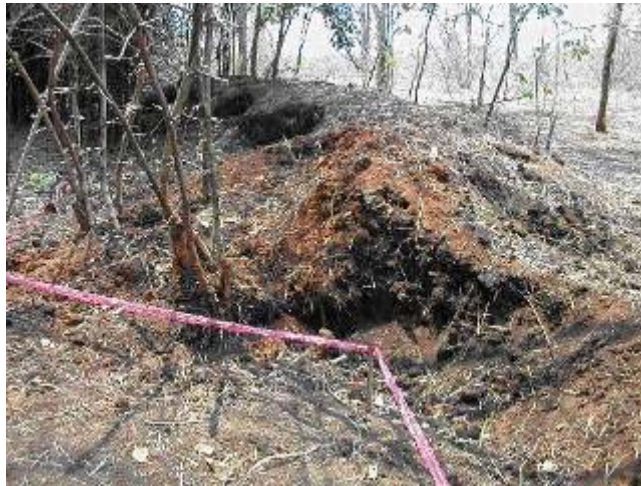
[The Victim], Id 931799, Section Commander, approached to the head of the clearing lane of the minefield M4101 where one deminer of his section reported that a mine was found, then picked up a trowel of the breaching team without wearing PPE excavated soil to identify the item found, as reported by the deminer, while doing soil excavation the trowel hit the top of the mine underneath. It exploded.

[The accident area, showing the point of detonation.]

For the case 04 March 04: Based on the nature of the injury and answers of the victim, it was caused by PMN Anti-personnel Mine while he was excavating soil, without wearing PPE, to identify item found as reported by a deminer in his section. The trowel slipped and hit the top of the mine. It exploded causing serious injuries to his face, neck and arms.
