DDAS Accident Report

INVESTIGATION REPORT INTO MINE ACCIDENT

WHICH OCCURRED ON 04th MARCH 2004 AT M4101 MINEFIELD, O'Chrey Village, Kamreing Commune, Kamreing District, Battambang PROVINCE

REPORT PREPARED BY: DEPUTY DIRECTOR, PLANNING AND OPERATIONS

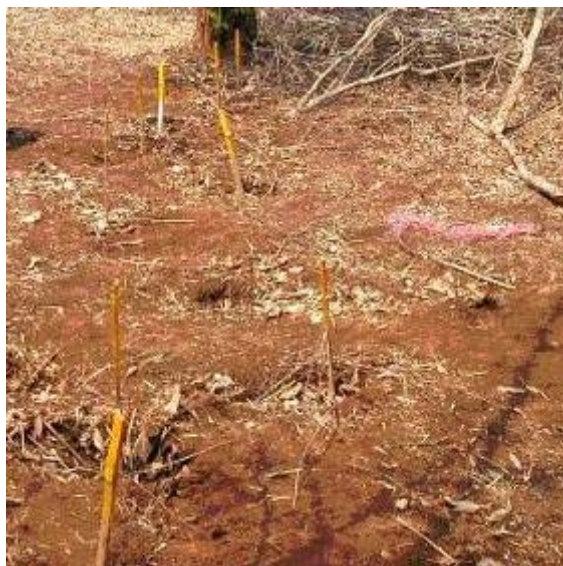
[Photograph showing discovered mine-line marked with yellow topped stakes.]

The Victim deliberately walked outside the marked area, using a path that he and others frequently used. The line of previously discovered mines was close to, but inside, the perimeter tape. Clearly the hazardous area had not been marked appropriately during survey. That is not unusual because accurate survey is very difficult, but it is why the primary cause of this accident must be listed as “Inadequate survey”.

The secondary cause is listed as a “Field control inadequacy” because the extent of the hazardous area had not been appropriately adjusted after a mine line had been found. Generally, a distance of at least five metres (normally ten) on both sides of a mine-line will be cleared. This is intended to catch “strays” that may have been moved by weather or may have been used to “patch” the original mine-line after mines have detonated. If this had been done, the mine just outside the perimeter tape would have been found during clearance.

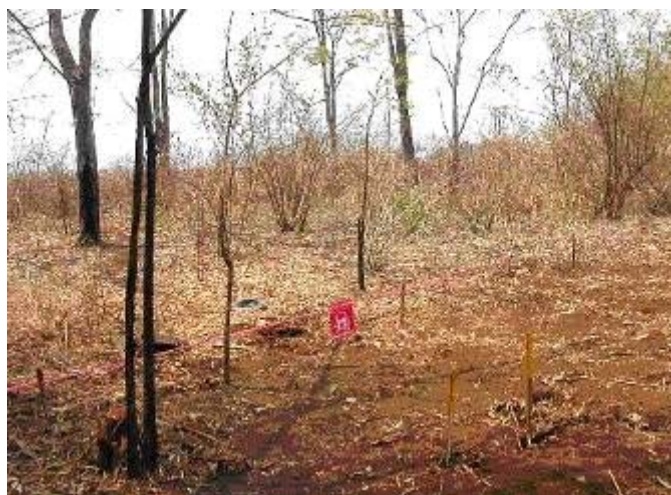
[The accident site, the Victim's hat can be seen where it fell.]

For the case 09 March 04: Based on the nature of injury, the answers of the victim and the scrape at the accident spot [crater], it was caused by PMN Anti-personnel mine while he was stepping out the cleared minefield boundary to go to toilet in the forest.

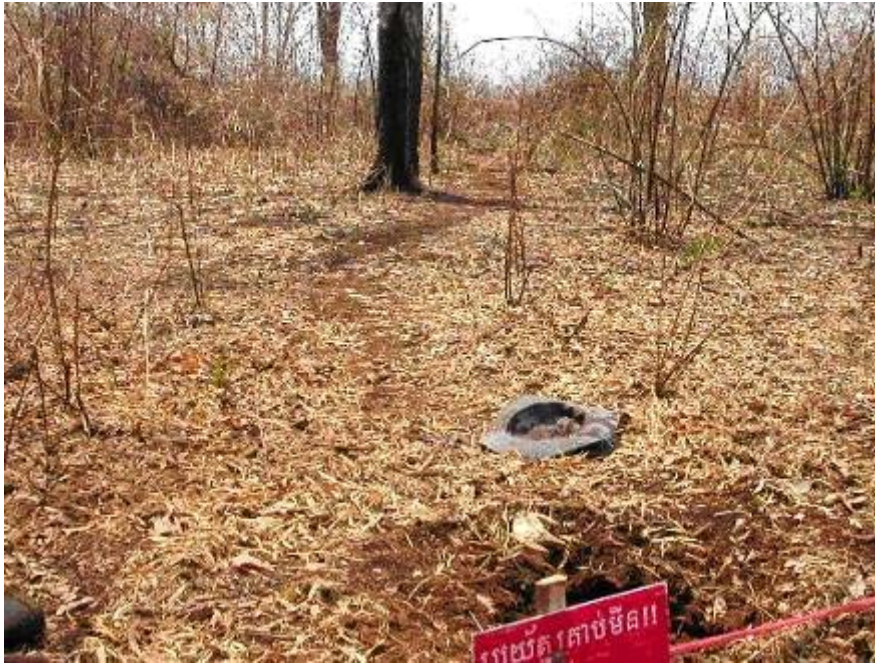
Yes. It breached Manual Demining SOP 108. The victim himself ignored the boundary of minefield even though it was clearly marked, he might perceive the hazardous area as a safe track where he saw villagers frequently walking through and he sometimes walked along that track as well.

[A photograph showing footpath, accident site and Victim's hat is shown below.]

The crater is 0.5 m from boundary of minefield and on the edge of the walking track.

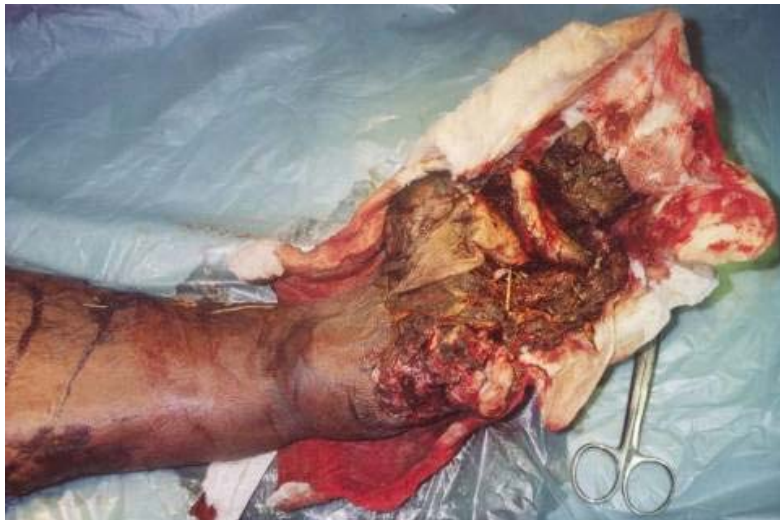
Right foot.

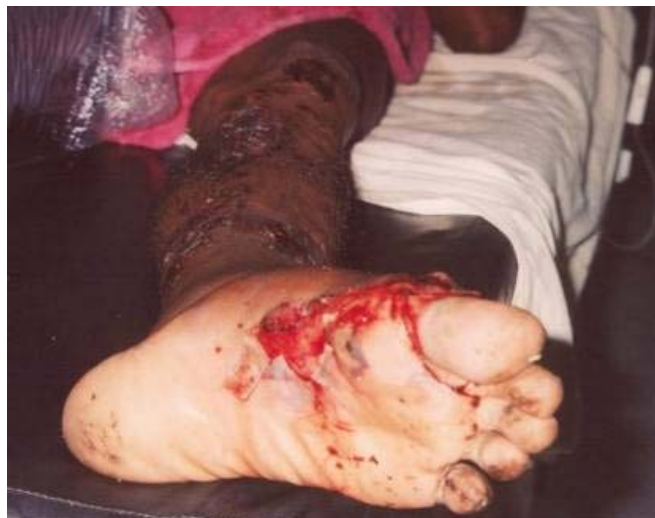
Left foot and leg.

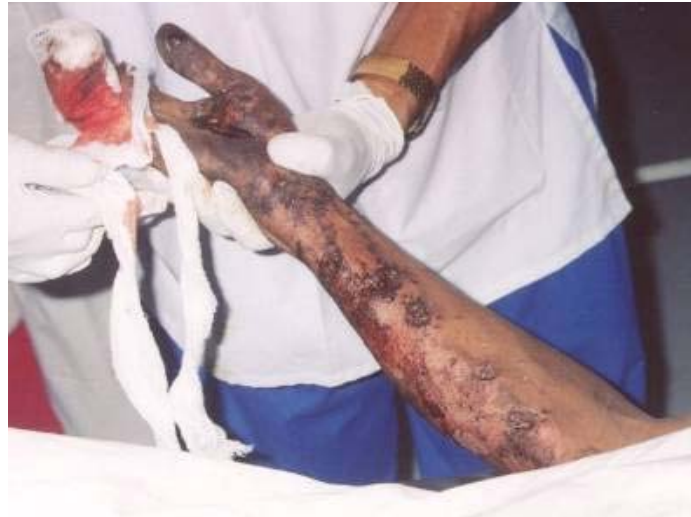
Right arm
