# DDAS Accident Report

<b>Report date:</b> 29/01/2008	<b>Accident number:</b> 533
<b>Accident time:</b> 09:10	<b>Accident Date:</b> 22/09/2004
<b>Where it occurred:</b> MF011, Salahley Municipality, Nr Ina Guuxaa, Salahley District, Galbeed Province	<b>Country:</b> Somaliland
<b>Primary cause:</b> Field control inadequacy (?)	<b>Secondary cause:</b> Victim inattention (?)
<b>Class:</b> Excavation accident	<b>Date of main report:</b> 22/09/2004
<b>ID original source:</b> None	<b>Name of source:</b> [Name removed]
<b>Organisation:</b> [Name removed]	
<b>Mine/device:</b> P2Mk2 P4Mk1 AP blast	<b>Ground condition:</b> dry/dusty hard
<b>Date record created:</b>	<b>Date last modified:</b> 29/01/2008
<b>No of victims:</b> 1	<b>No of documents:</b> 1

At 09.10hrs on the 22nd of September 2004, deminer [the Victim] was carrying out manual clearance using the prodding method on the northern side of Minefield 0011 at Ina Guuxaa.

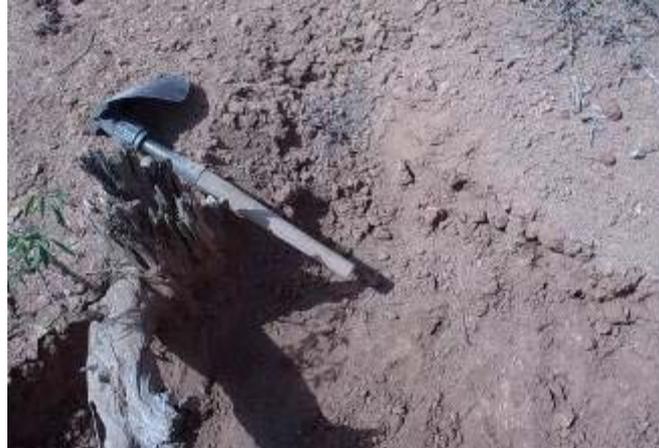
Whilst excavating earth at the front of his lane, he inadvertently detonated what is suspected to have been a P-4 anti personnel mine.

- The use of the excavation tool was inappropriate and probably contravened [Demining group] demining SOPs.
- In combination, this resulted in the deminer failing to locate the mine with his prodder, and subsequently, for it to be detonated through use of the excavation tool with excessive force and in all probability, in a downwards rather than horizontal manner.

Equipment damage, [to mattock] \$25

[The damaged shovel is shown above beside the crater.]

Due to the seriousness of this incident all deminers from MF011 will carry out remedial training on the 23rd of September 2004. [The Victim] will be disciplined accordingly by [Demining group].

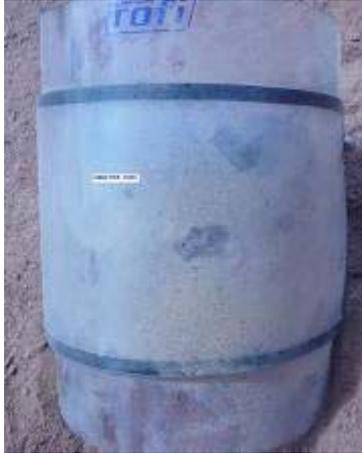
[The Victim's visor, marked by the impact of the shovel or parts of the shovel, is shown above. There was some light fragmentation marking on the right shoulder of the frontal apron.]

The P4 is a very small mine (30g Tetryl), which is probably why the Victim escaped without injury. The shovel was damaged and pieces broke off which could have penetrated the visor had the mine been larger. But the fact of using a tool with a long handle may have prevented hand injury even though the tool was not designed to stay in one piece.

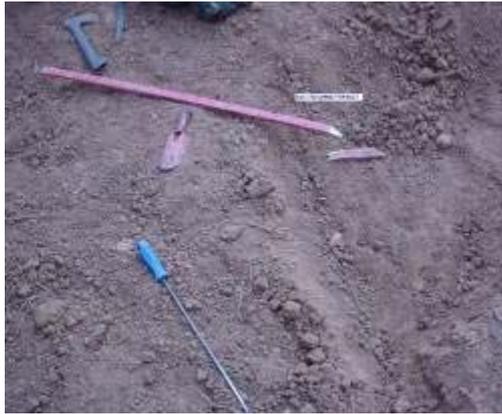
The tools available to the deminer are shown in the picture below and were inappropriate. They are not blast resistant or designed for purpose. The folding shovel has the same faults and does not meet the recommendations within the IMAS.

Although the probe is long it has a hard and brittle handle. The trowel is too short and made using thin mild steel pressed into shape. Examples have broken up and entire trowel heads have been found inside deminers after blasts. The need for an axe is unexplained.
