DDAS Accident Report

Report date: 29/01/2008	Accident number: 535
Accident time: Not recorded	Accident Date: 10/12/2005
Where it occurred: MF14, Bisqua town, Duruqsi District, Togdheer Province	Country: Somaliland
Primary cause: Unavoidable (?)	Secondary cause: Unavoidable (?)
Class: Excavation accident	Date of main report: 12/12/2005
ID original source: None	Name of source: [Name removed]
Organisation: [Name removed]	
Mine/device: P2Mk2 P4Mk1 AP blast	Ground condition: hard route/path
Date record created:	Date last modified: 29/01/2008
No of victims: 1	No of documents: 1

Accident site: MF14, Bisqua town, Duruqsi District, Togdheer Province

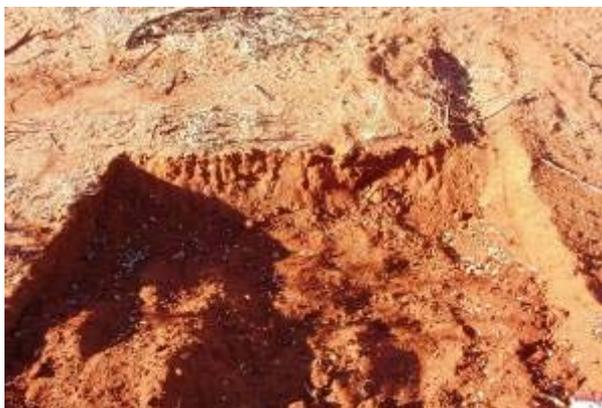
[The mine detonated top right as the Deminer reached forward to start raking the next area.]

The area where the mine detonated was on an old road which went through that part of the mine field and this meant that the ground is much more compact than would have normally been expected.

The primary and secondary causes of this accident are listed as “Unavoidable” because the investigators found that the Victim was probably working as trained and that the ground was unusually hard in that place. The photographs show no obvious visual clue that the old road ran across the working area at this place.

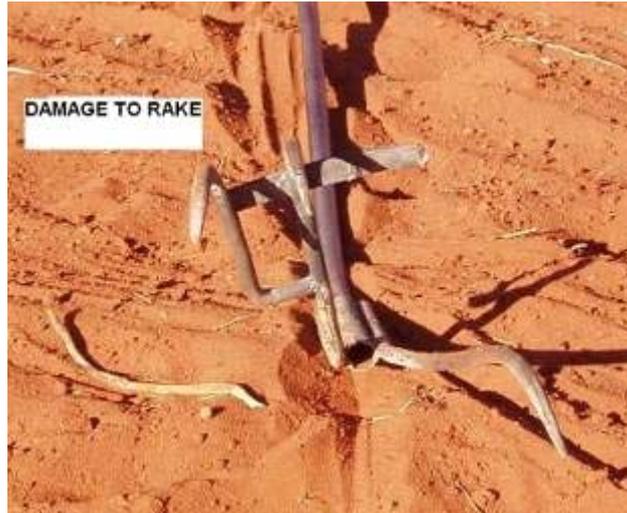
- Antipersonnel mine model P4 exploded during mine-clearance in minefield MF 014, Bisqua.
- Explosion occurred when deminer [the Victim] was carrying out clearance using the raking method.
- Through the investigation it was deemed that the A/P mine was approximately 2-5cm deep (from top cover)
- The deminer received no injuries from the mine blast.
- The deminer's rake received damage from the mine blast. (See photo Attached)

[The damaged four-tine rake head is shown above. Its design impedes the escape of the blast wave and so is more likely to break up than a two-tine rake. The use of a metal pipe as a handle could also have added to the tool's weight, so making it easier to "hack" the ground roughly.]
