DDAS Accident Report

Report date: 29/01/2008	Accident number: 540
Accident time: 11:28	Accident Date: 08/10/2004
Where it occurred: Erlalai Municipality, Valikamam South, Jaffna, Northern Province	Country: Sri Lanka
Primary cause: Unavoidable (?)	Secondary cause: Unavoidable (?)
Class: Excavation accident	Date of main report: 08/10/2004
ID original source: None	Name of source: [Name removed]
Organisation: [Name removed]	
Mine/device: P2Mk2 P4Mk1 AP blast	Ground condition: agricultural (abandoned) bushes/scrub residential/urban soft wet
Date record created:	Date last modified: 29/01/2008
No of victims: 1	No of documents: 1

Demining accident description: Mine clearance was on-going in minefield LK-148, Mallakam, when blast occurred at 11:28 am.

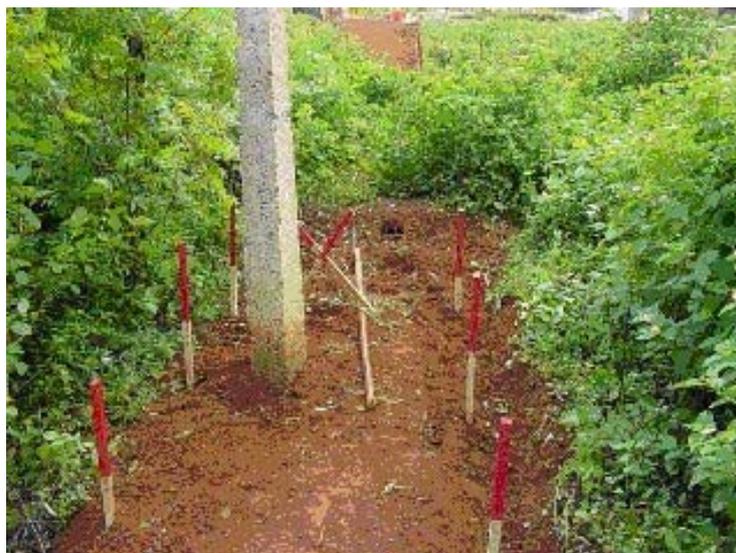
Type of area: city [Actually urban garden: the researcher visited the site.]

[The accident site.]

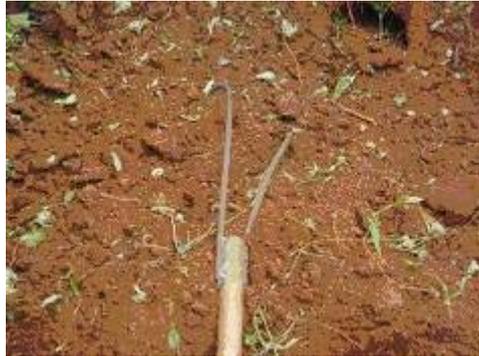
Deminer [the Victim] used his rake in normal manner. He set off a P4 MK1 antipersonnel mine with his 2-tooth heavy rake. Heavy rake bended but remained in one piece in the blast. Deminer was in perfect health and didn't get bruises nor other minor injuries.

[The rake tines were splayed in the blast.]

Some doubts about the suitability of the rakes in use were raised at the time, and the criticism not well received by the demining group. Many rakes seen in this demining group’s minefields had no (or very reduced) curvature and so the tines had the downward pointing spikes associated with a garden rake. When the rake is placed in front of the deminer and pulled back towards him, it is meant to dig itself in. When the rake tines are straight, it is tempting to hit the ground with the rake head to get some penetration before drawing the rake head forwards. The photograph of the damaged rake head accompanying this accident report shows reduced curvature, but that could have been the result of the blast.

The type of rake in use would not be suitable for use when larger AP blast mines were anticipated because the rake head would almost certainly break apart in a blast.

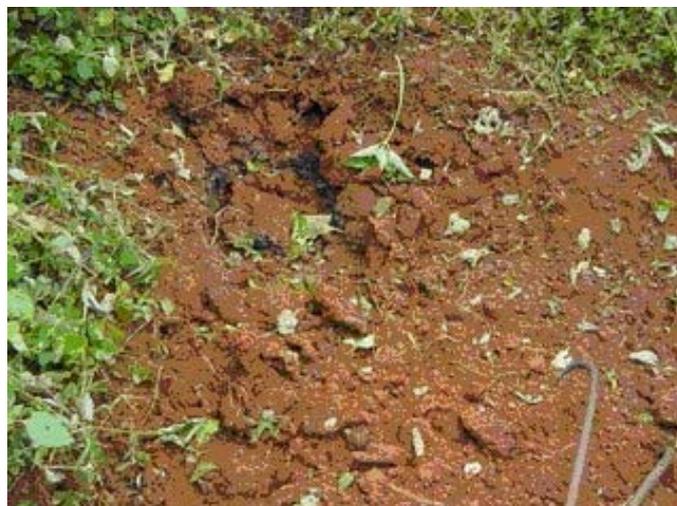
Shape of the explosion crater is small 30 cm x 30 cm x 15 cm and perfectly round shaped, which slightly leads to a conclusion that P4 was laid in normal horizontal (pressure plate upwards) position. It is possible, that P4 was damaged and missing parts of its pressure plate and therefore more sensitive.

[The crater is shown above, fairly round in shape.]
