# DDAS Accident Report

<b>Report date:</b> 30/01/2008	<b>Accident number:</b> 541
<b>Accident time:</b> 12:30	<b>Accident Date:</b> 09/10/2007
<b>Where it occurred:</b> Nr Jaffna, Kaithady subdistrict, Chavakacheri District, Northern Province	<b>Country:</b> Sri Lanka
<b>Primary cause:</b> Field control inadequacy (?)	<b>Secondary cause:</b> Unavoidable (?)
<b>Class:</b> Excavation accident	<b>Date of main report:</b> 03/11/2007
<b>ID original source:</b> None	<b>Name of source:</b> [Name removed]
<b>Organisation:</b> [Name removed]	
<b>Mine/device:</b> Type 72 AP blast	<b>Ground condition:</b> clay dense vegetation soft trees
<b>Date record created:</b>	<b>Date last modified:</b> 30/01/2008
<b>No of victims:</b> 1	<b>No of documents:</b> 1

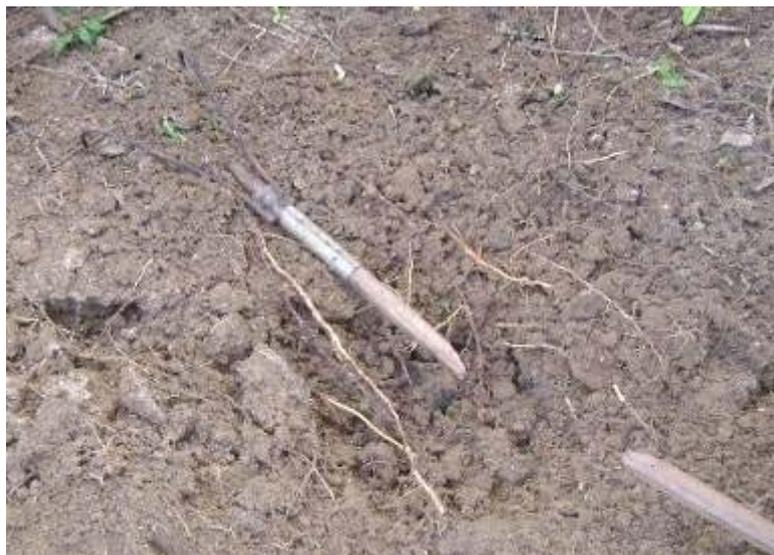
On the time of the incident [Name removed] was carrying out mine clearance by raking method in a lane where he earlier had found 7 AP mines Type 72. The area he was raking was free from vegetation and no large tree roots or any other obstacles was in the near vicinity of the ground where he was raking. The soil conditions were loose clay. The Team Leader had been checking the deminer 10 minutes before the incident and the section leader had left his lane just a few minutes before the incident. [The Victim] did by raking detonated a mine (most likely a Type 72) which broke off the rake handle and made the rake bend but not break.

[The broken rake handle and bent tines.]

Due to the soil conditions and the fact that there were no major obstacles at the scene of incident it is most likely that [the Victim] has mis-used his rake and by force struck the ground which set of the mine. The Team Leader has on several occasions reminded his team to be careful since it is a minefield which is densely mined and also since they had an accident in the same minefield on the 9<sup>th</sup> of October.

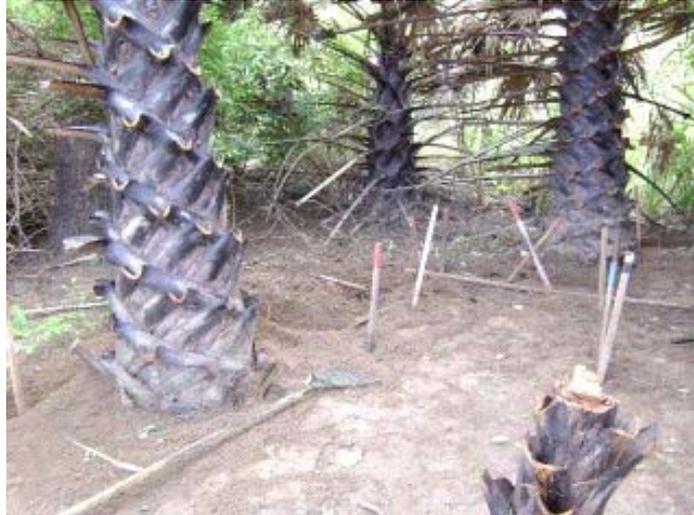
[The accident site.]

The Primary cause of this accident is listed as a "Field control inadequacy" because the investigator determined that the ground was easy to work in and the deminer was working too roughly with the rake, but his error was not corrected. Photographs show that the ground was not without some root systems, so the secondary cause is listed as "Unavoidable" because it may be that the Victim was working as trained when the accident occurred.
