DDAS Accident Report

Report date: 02/02/2008	Accident number: 547
Accident time: 11:05	Accident Date: 22/08/2006
Where it occurred: Task # 709, Nr Paktia Kot, Ward 12, Central District, Kabul Province	Country: Afghanistan
Primary cause: Field control inadequacy (?)	Secondary cause: Management/control inadequacy (?)
Class: Missed-mine accident	Date of main report: 28/09/2006
ID original source: OPS-27/412-06	Name of source: UNMACA
Organisation: [Name removed]	
Mine/device: PMN AP blast	Ground condition: dry/dusty grass/grazing area rocks/stones
Date record created:	Date last modified: 02/02/2008
No of victims: 1	No of documents: 2

Demining Investigation Report

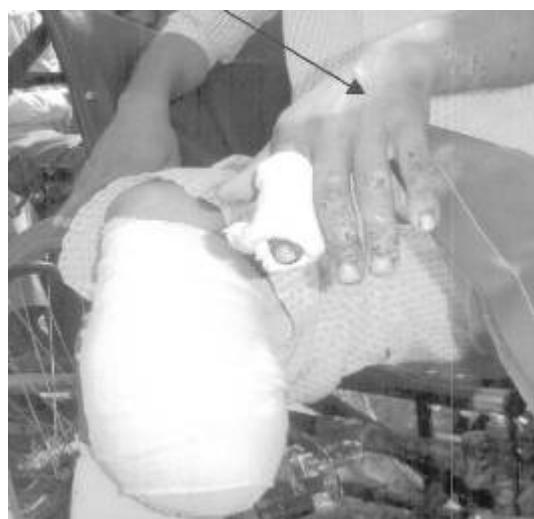
[The victim with amputated right leg and injured left leg and left hand.]

5- Amputation of RT leg also RT hand and left leg got injured

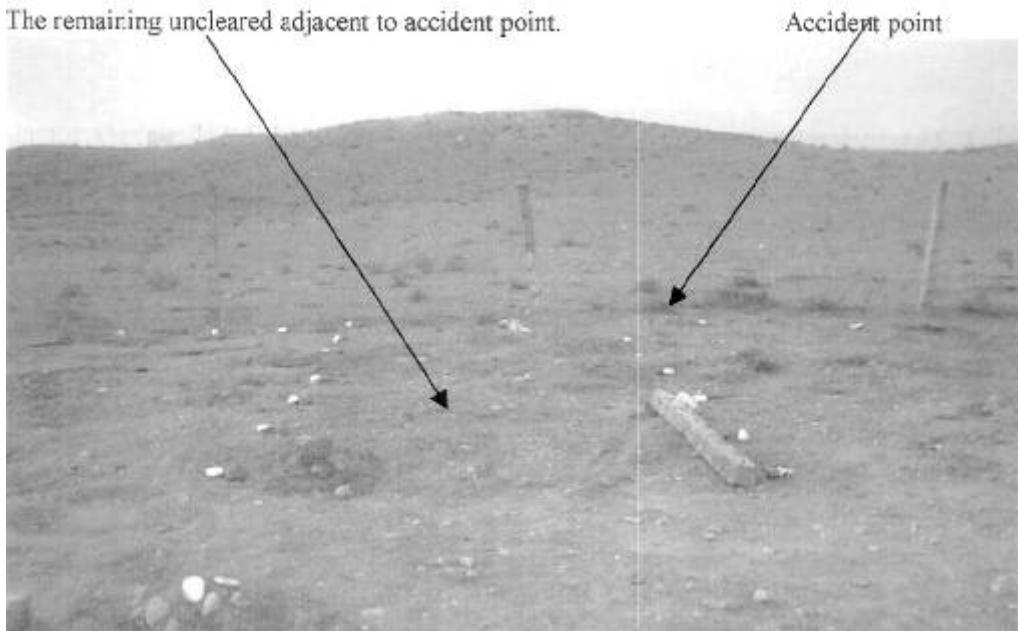
Site conditions: The terrain was hillside. The ground was soft. The weather was clear, calm and warm. There was no or light vegetation.

[The accident site was very open and relatively flat.]
