# DDAS Accident Report

## Demining Investigation Report

Date of incident/accident: 22 December 2005

Location: Former Border Regiment-5, Dopushta, Injil District, Herat Province

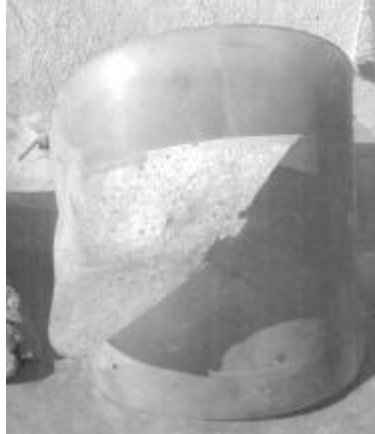
[The Victim's visor: the disposable scratch guard was heavily damaged.]

The damage to the vest was minimal and there was no damage to the lower protective piece that covers the knees and legs. This lack of damage and his injuries indicates the deminer was sitting/squatting with the lower protective piece between his legs and was not kneeling and thereby exposed his right knee to the detonation. All the blast fragmentation damage was also along the right side of the vest and visor further indicating he was facing sideways when the mine exploded. There is only damage, to the right side of the visor. The deminer was not kneeling and fully protected when the accident happened.

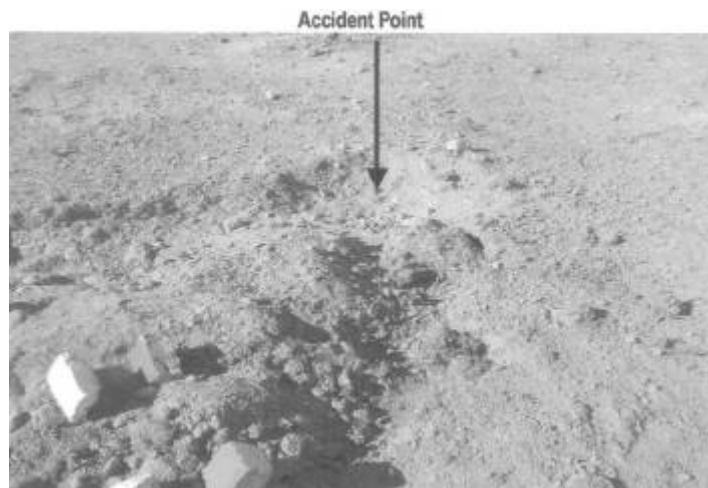
Site conditions: The terrain was flat and open. The soil was medium hard and dry. The weather was clear, calm and mild. The vegetation was grass [none].

[The accident site.]
