DDAS Accident Report

INDEPENDENT INVESTIGATION REPORT 010/2007

[International demining NGO] BAC INCIDENT

AT TASK CBU-193 B/D 5th July 2007

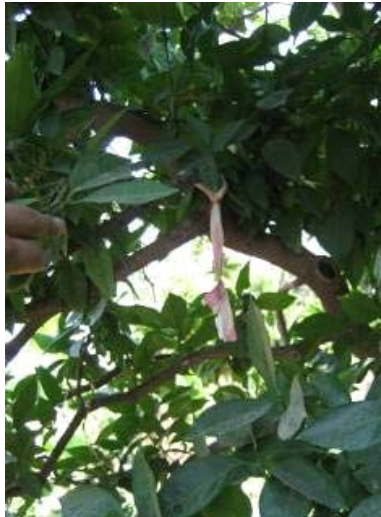
The items were found, neutralized and removed from the originally place of find by farm workers. Place from where the sub-munition (M46) had been removed was a branch knob of a lemon tree. The item was to have been hanging on the branch knob of a lemon tree, aside the farm road, 1-2m inside grown lemon trees and just about 10m away from the water pump facility.

The M46 which was hanging in a lemon tree and just 1-2m away from the farm road is very difficult to be missed if you passing every day through the area, and while conducting BAC procedures, searchers are cutting some branches to make the way into the plateau.

The suggestion that any missed devices would have been seen should be viewed in context, The picture below shows the place where the M46 was reportedly found.

The foliage makes it credible that it could have been missed.

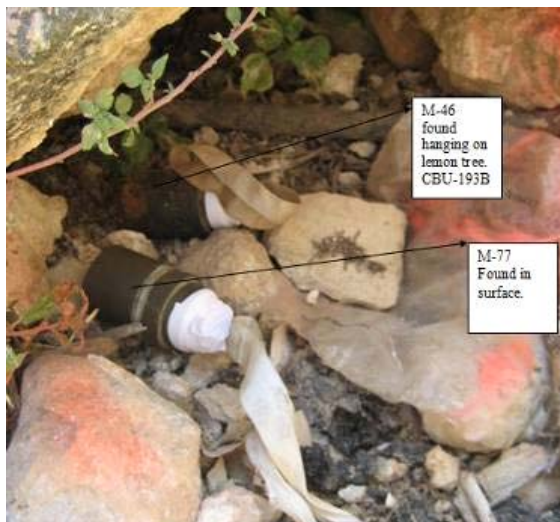
Both items had the ribbon intact, the M77 did not have any physical damages or rust of any significance possible indicating that it had not been in contact with the ground or exposed to the elements. The M46 had rust on one half of the casing, most of the rust on the lower portion possible were it was in contact with the ground.

The picture above shows the two devices where they had been moved after tapping around the arming mechanisms.

While it is unlikely that a submunition left hanging in a tee would rust on one side, a submunition pressed into the ground for a significant period would probably do so. Because the two munitions are similar and had been moved prior to the investigators seeing them, one

cannot be certain which was in the tree and which on the ground. The people who found them may not have thought the distinction of any great significance.

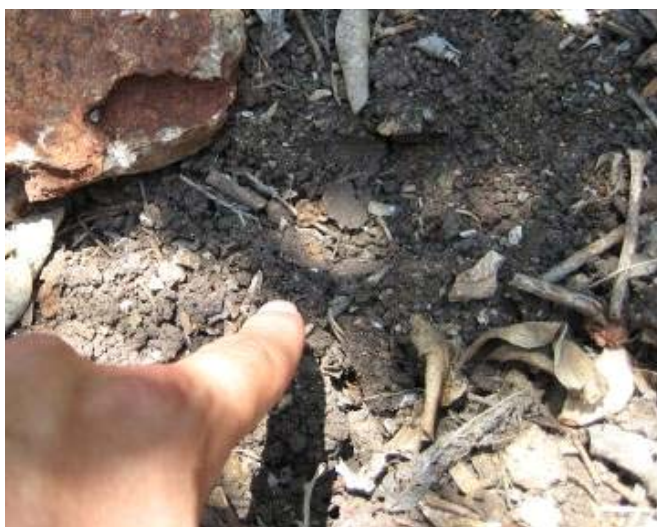
The place from where the sub-munition (M77) had been removed was still obvious and it was therefore, possible to locate the imprint. The item was situated beside the farm road, in a corner of one plateau, 1-2m inside of the orange orchard. The vegetation was low-medium on surface.

The picture above shows the site where the M77 was reported to have been found.
