DDAS Accident Report

Report date: 07/02/2008	Accident number: 559
Accident time: 10:30	Accident Date: 10/01/2007
Where it occurred: UNIFIL002 CBU-33, Zibqin Village, Nr Tyre Cty, Tyre District	Country: Lebanon
Primary cause: Unavoidable (?)	Secondary cause: Inadequate training (?)
Class: Demolition accident	Date of main report: 21/01/2007
ID original source: None	Name of source: UNMAS
Organisation: [Name removed]	
Mine/device: Ordnance	Ground condition: rocks/stones
Date record created:	Date last modified: 07/02/2008
No of victims: 1	No of documents: 2

Minefield Task Number: UNIFIL002 CBU-33

SUBJECT: INVESTIGATION REPORT ON THE ACCIDENT AT THE [UN Military PK force] DEMINING SITE.

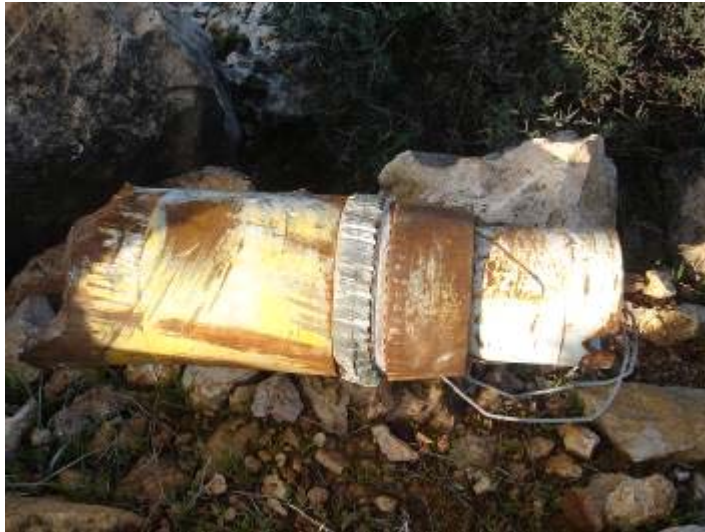
TYPE OF INCIDENT: Burning injury by an unexploded 155 mm illuminating shell (half body remains with explosives visible outside) on demolition site.

[The illumination shell.]

Conclusion: Whenever a damaged UXO is located, demolition should be carried out in-situ and no removal and direct contact is allowed.

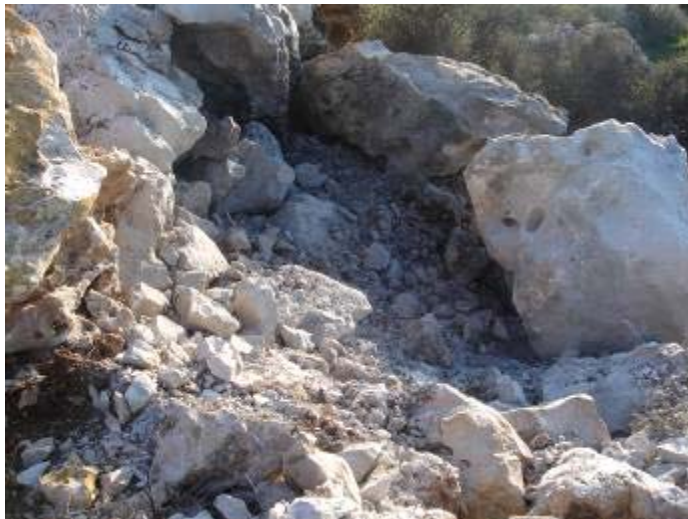
[The accident site.]

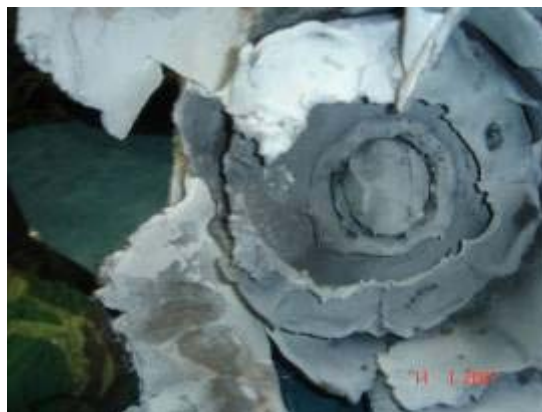
[The device did not detonate, merely burned, and was photographed again after it had burned out.]

We are strongly believe that the explosion happened, because there are still a white powder in the illuminating canister in the rear part of the UXO. Any friction or disturb for the white powder make a chemical reaction, a flame will occur and after that explosion will take place for the detonator and TNT Charge that was placed by the deminer for disposal. The white powder was disturbed for unknown reason, which it caused the flame and explosion, [the Victim] gets injured because of the flame.

All kinds of illumination UXO should be disposed in Situ unless it is located in built up area, it is required to move or relocate the UXO to safer place.

DO NOT disturb the white powder.

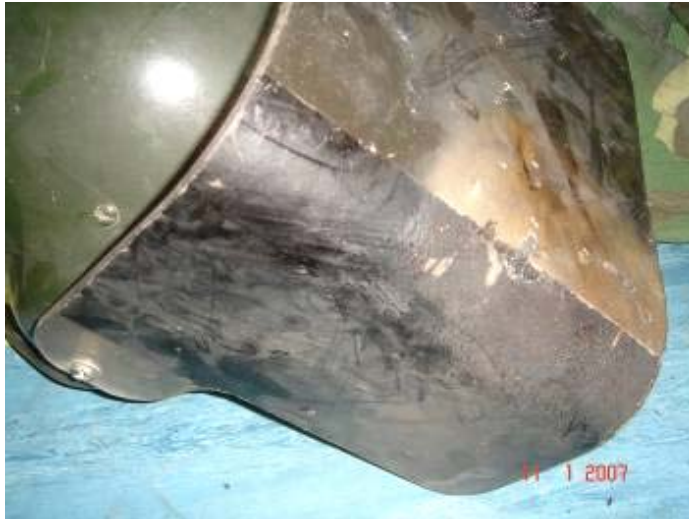
The flame get under the visor where no protection for the neck.

Without a Medical report it is unclear whether the Victim’s eyes were affected. A photograph showed the top of his protective vest burned through, showing that the flames struck jim in the neck area. The visor used was a cold pressed polycarbonate visor attached to a combat helmet

The sides appear to have been painted to prevent glare, and the front appears flame damaged – possibly on the inside – but with some marks on the outside.

During the examination, relocating or disposal procedures for the UXO, at least it is required to wear PPE EOD-7B during the whole process of disposal.

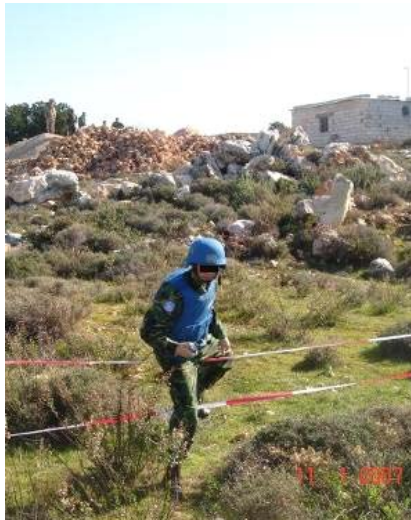
As is frequently the case, the internal investigators seemed to enjoy taking photographs of each other without visors and even when stepping outside the marked area.

The investigators from the National MAC also recommended that the investigators should carry metal-detectors when on site. A metal detector would certainly have made it safer to move around in relative safety.
