DDAS Accident Report

Report date: 08/02/2008	Accident number: 562
Accident time: 10:26	Accident Date: 23/08/2007
Where it occurred: Task No: 6-015, DA CBU No. 585, Near Najdh	Country: Lebanon
Primary cause: Unavoidable (?)	Secondary cause: Field control inadequacy (?)
Class: Handling accident	Date of main report: 25/08/2007
ID original source: None	Name of source: UNMAS
Organisation: [Name removed]	Ground condition: bushes/scrub leaf litter rocks/stones trees
Mine/device: DPICM M77 submunition	Date last modified: 08/02/2008
Date record created:	No of documents: 1
No of victims: 1

Task No: 6-015, RECCE 1: DA CBU No. 585

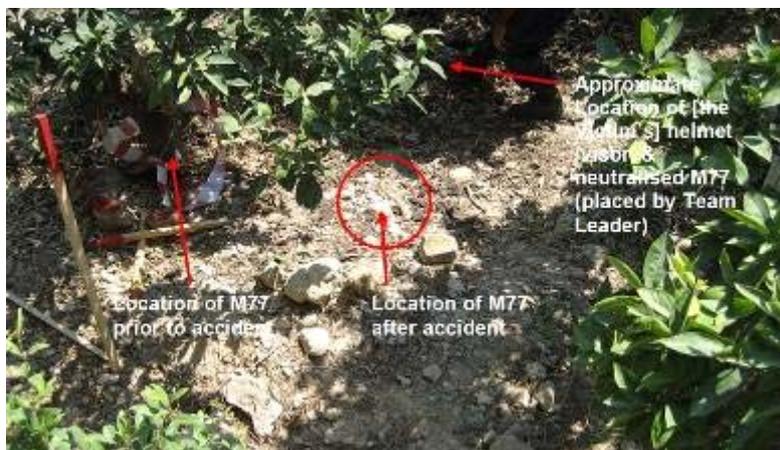
[The victim was handling a device when the accident occurred. Another “gagged” device was close by.]

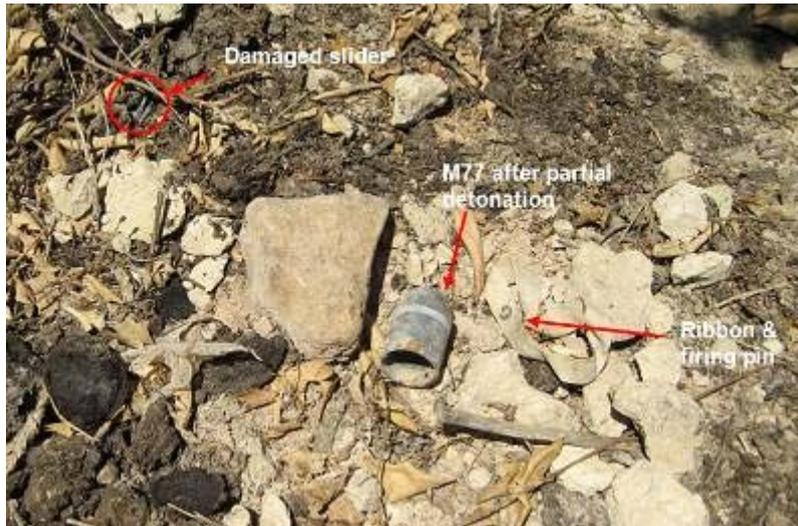
[The M77 partially detonated in the Victim’s hand, but the main charge did not explode. The picture below shows the device afterwards, with the firing pin and ribbon separated.]

The M77 involved in this accident did not detonate properly and may have been damaged. If this was visible, it would imply that the Victim made an error by touching it. But if the damage was not visible, the Victim was just extremely lucky.

The primary cause of this accident is listed as "Unavoidable" because it seems that the Victim may have been operating as instructed and the accident occurred due to a device that was damaged and unstable, but not obviously so.

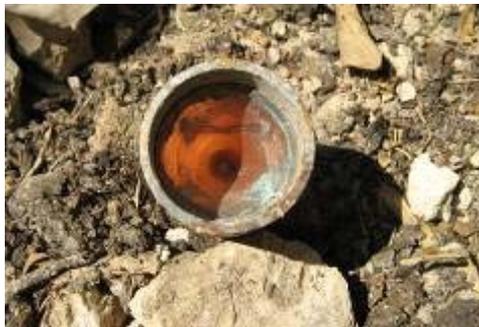
[The copper cone of the shaped charge inside the M77 was visible at one end, and the high explosive fill at the other.]

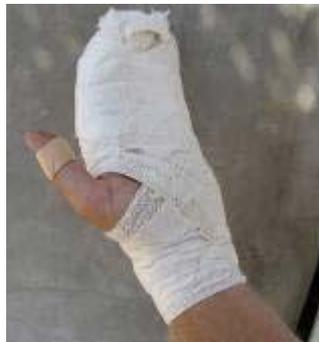
[The Victim's right hand was injured.]

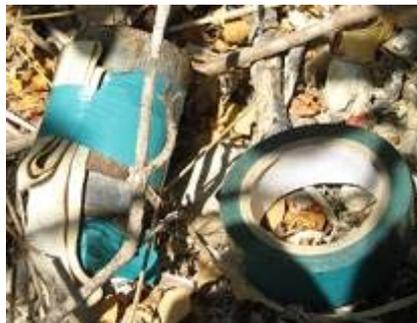
[Pictures of the site and the prodding tools showed that clearance was being conducted, but there was no indication of any detectors that would have allowed sub-surface clearance.]

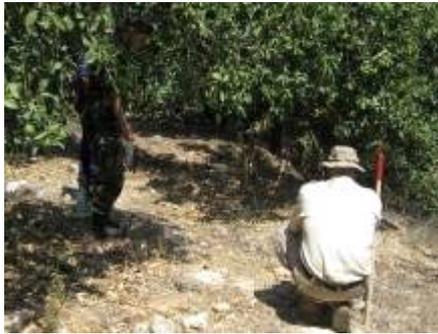
[Pictures of the investigators at work showed that they did not wear PPE.]

The failure of the demining group’s investigators to wear PPE at the site is common, but sets a bad example.
