DDAS Accident Report

Accident details

Report date: 09/02/2008	Accident number: 563
Accident time: 12:28	Accident Date: 05/07/2007
Where it occurred: Area 8-003 CBU 434, Nr Tyre, Tayr Debba Municipality, Sur Sub- district, El-Jenoub Province	Country: Lebanon
Primary cause: Field control inadequacy (?)	Secondary cause: Management/control inadequacy (?)
Class: Missed-mine accident	Date of main report: 12/07/2007
ID original source: 07/2007	Name of source: UNMAS
Organisation: [Name removed]	
Mine/device: DPICM M77 submunition	Ground condition: bushes/scrub dry/dusty metal fragments rocks/stones steep slope
Date record created:	Date last modified: 09/02/2008
No of victims: 2	No of documents: 1

BOI Investigation report

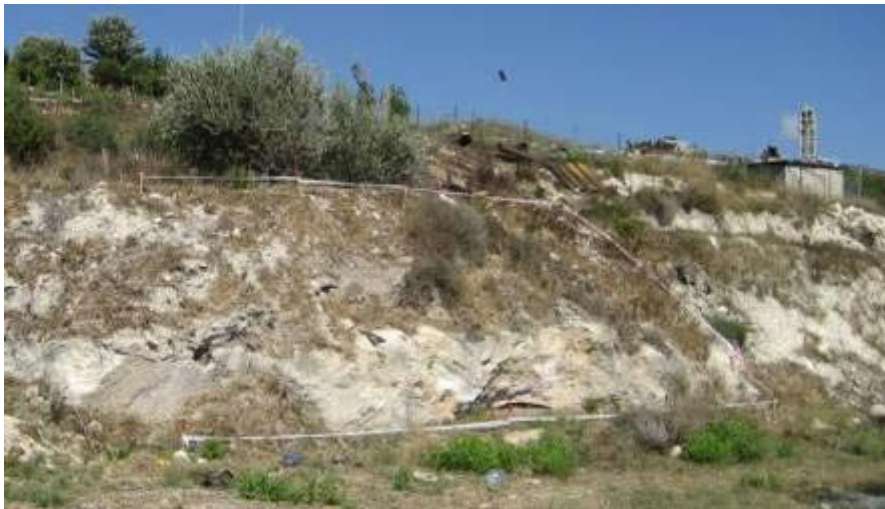
[The site on the steep side of a ridge. The point of detonation is roughly central in the photograph below.]

[Victim No.1] is believed to have been moving from the working area and accidentally slipped on the steep ground disturbing the partially buried M77, causing it to function.
