DDAS Accident Report

BOARD OF INQUIRY (BOI) REPORT 003/2007

on [International demining company] INTERNATIONAL LIMITED DEMINING ACCIDENT that occurred on the 05th March 2007 in which a [International demining company] Deminer was injured

Ref No. 03/2007

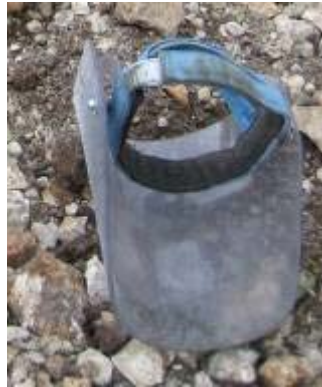
The ballistic visor had been positioned in the adjacent lane (near the demining tools and detector) by [International demining company] during the casevac process. The visor was

examined at the site by the MACC investigation team on 05 March and by the BOI team on 06 March 2007, at the [International demining company] office in Nanbatiyah. The visor is still complete with the headband in place. The exterior of the lens is covered in shallow indentations / scuff marks which it is believed was caused by rock fragments from the explosion. The exterior of the lens is covered in a thin layer of dirt / dust. The interior of the lens is slightly dirty / dusty which is more evident on the left side. There are no holes or cracks in the visor. **The condition of the visor indicates that it was being worn correctly at the time of the accident.**

[The Visor: see Analysis.]

The visor was raised because facial injuries extending to the Victim’s forehead could not have occurred if the visor has been in its correct position. The Victim’s eyes were probably saved by the fact that this demining group (uniquely at the time) wore industrial safety spectacles as well as the visor, and the spectacles were in place. They were broken in the blast and a photograph of one “arm” of the spectacles under a rock is shown below.

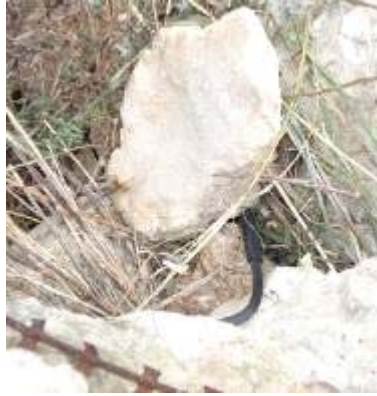
The demining group started to wear industrial safety spectacles underneath the visor after a series of visor failures in Lebanon. Subsequent investigation showed that the visors involved had been in service for many years and had probably been hardened by UV exposure. See Accident No. 383, for an example.

The picture above also shows razor wire, which was present at the accident site and may have made metal-detector use unreliable.
