DDAS Accident Report

Report date: 15/04/2008	Accident number: 569
Accident time: 11:40	Accident Date: 18/06/2007
Where it occurred: MF 1580, Area 6-001, Kafer Houna, Jezzine South, District-Jenoud	Country: Lebanon
Primary cause: Management/control inadequacy (?)	Secondary cause: Field control inadequacy (?)
Class: Excavation accident	Date of main report: 27/06/2007
ID original source: 06/2007	Name of source: UNMAS
Organisation: [Name removed]	
Mine/device: No.4 Israel AP blast / frag	Ground condition: hard metal scrap rocks/stones steep slope
Date record created:	Date last modified: 15/04/2008
No of victims: 1	No of documents: 2

BOARD OF INQUIRY (BOI) INVESTIGATION REPORT

Ref: 06/2007

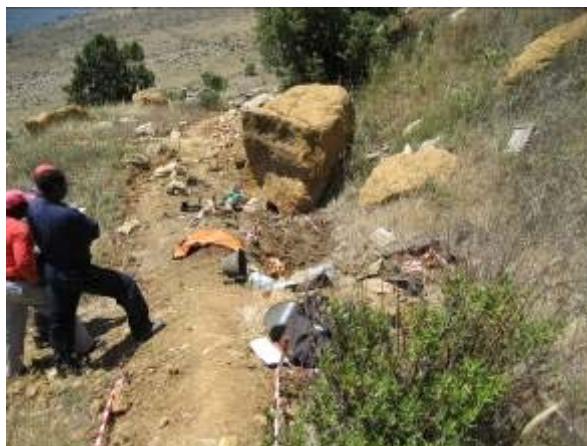
[Photographs taken by the internal demining group investigation showed staff not wearing PPE.]

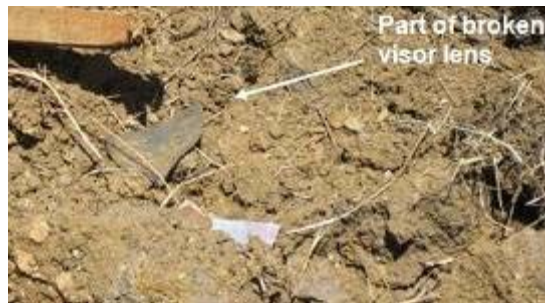
According to information gained during the interview process, the Team Leader had seen [the Victim] wearing his PPE consisting of body armour, visor and inner safety goggles, correctly. The only visor evidence at the accident site was part of the lens which was positioned in the front / left side of the clearance lane and the harness. The broken lens was dirty and in the proximity of clumps of earth which appeared to be burnt. The visor harness was visible a few metres slightly forward and left of the clearance lane on the bank of the hill in an uncleared area. The lens was not attached.

[See Analysis.]

This evidence and the injuries sustained by the casualty indicate that the visor had been worn at the time of the explosion. The colour and shape of the lens fragment indicates that it had been broken off from the edge of the visor during the explosion and the location of the harness signifies that the visor had been pulled from the deminer’s head by the blast from the explosion. There was no other visor evidence in the immediate accident area which suggests that it had either shattered or been thrown into another area.

The secondary cause is listed as a "*Field control inadequacy*" because the Victim suffered severe facial injury, including amputation of a lip, loss of teeth and loss of at least one eye. This indicates that the visor was not being worn correctly. It was raised and the field supervision should have corrected this.

It should be possible to conduct a thorough examination of the lens fragment and visor harness after additional clearance of the lane has been conducted.

- i) Supervisory staff should ensure that PPE is worn correctly at all times when working in the hazardous area. Consideration should be given to the use of helmets in conjunction with the visor when operating in mountainous / rocky conditions. It is however, understood that the balance between comfort and safety is a key factor when selecting appropriate PPE.

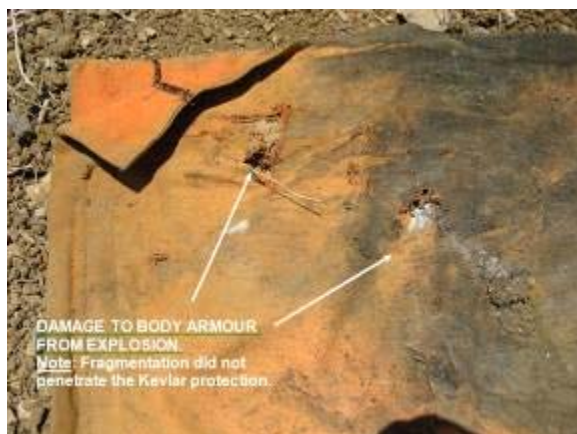
The body armour is a one-piece 'apron style' design and comprises Kevlar protective material which covers the neck, chest, abdomen and groin regions of the body. The apron was covered in dirt and blackened through the blast effects of an explosion. There were tears on the outer cover primarily in the centre lower, right lower, right upper, right shoulder and right side of the collar which corresponds to the fragmentation effects of an explosion. There is evidence of blood on the right shoulder and around the rim of the collar. The Kevlar retained its integrity and the only evidence of penetration was a small hole on the seam of the collar.

[The apron is not made from Kevlar but a cheaper ballistic aramid. The position of its collar and the STANAG V50 rating of 380 m/s mean that it does not meet IMAS (as formulated in 2007).]

- l) The condition of the apron indicates that it had been worn correctly and that the right side took the brunt of the explosion.
- m) There is no evidence to suggest that the PPE was worn incorrectly by the casualty at the time of the accident. The type of PPE is in compliance with the NTSG and IMAS.

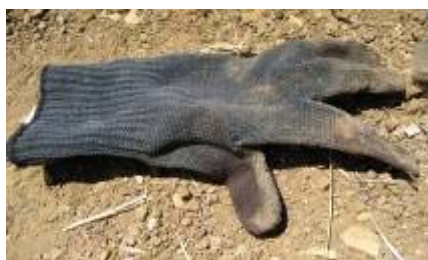
According to information gathered during the investigation, Aramid protective gloves had been worn by the casualty prior to the accident. It was only possible to locate the left hand glove at the accident site and its appearance corresponded to information that it was worn by the casualty at the time; dirt on the palm and fingers with evidence of blood stains. The absence of the right hand glove is consistent to the traumatic amputation of the casualty's right arm by the explosion.

[The glove that was not on the Victim's other hand. "Aramid" simply means nylon. There is no evidence that any aramid or Kevlar glove is of any value at close quarters to an AP mine blast.]

The issue of thin "aramid" working gloves is a novelty. Aramid is a nylon, and thin aramid could make severe burns worse by trapping the burning fragments (fragments "weld" themselves inside body armour at times). In order to be flexible, the gloves have to be thin. The protection offered by aramid varies by weave and by the number of layers used (12-16 layers is common), so the fragmentation protection the gloves offered must have been very low.
