DDAS Accident Report

Report date: 25/05/2008	Accident number: 572
Accident time: 10:23	Accident Date: 12/09/2007
Where it occurred: CBU 1038, Near Sidiqin village, Sur District	Country: Lebanon
Primary cause: Field control inadequacy (?)	Secondary cause: Field control inadequacy (?)
Class: Vegetation removal accident	Date of main report: 24/09/2007
ID original source: DS	Name of source: [Name removed]
Organisation: [Name removed]	
Mine/device: DPICM M42 submunition	Ground condition: agricultural (abandoned) bushes/scrub hard rocks/stones
Date record created:	Date last modified: 25/05/2008
No of victims: 1	No of documents: 1

1. An accident occurred at CBU 1038 which is located approximately one kilometre to the west of As Sidiqin a village in Sur District at 1023hrs on Wednesday 12th September 2007.
2. One person, [the victim]; aged twenty-seven was injured in the accident whilst conducting an intrusive visual surface search within allocated and marked boundaries as part of a Battle Area Clearance operation. After the accident he was transported to the Jabel Amel Hospital in Tyre where he was admitted and treated before being discharged after twenty – eight hours.
3. The [Demining

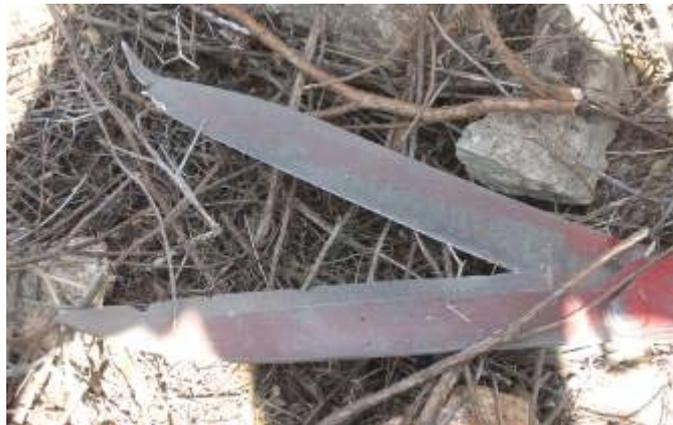
43. **Shears.** The shears are purchased locally for use in the cutting of visually or instrument assisted visually searched vegetation on the sites. The shears are damaged on the tips of the two blades, and were in close proximity to the explosion. [The Victim] stated that he was using the shears at the time of the accident. Photographs attached at Annex H. [Annexes were not made available.]

[Photograph sourced elsewhere. The short-bladed shears are not purchased locally but are part of a tool-kit sourced from Zimbabwe.]

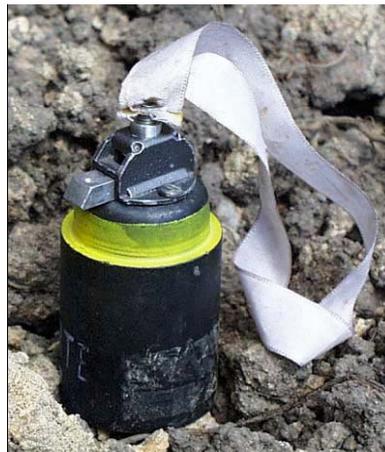
46. During the investigation of the crater several pieces of fragmented metal were recovered, although it is not possible to determine the exact sub-munition involved it is believed that it was an M42. This assumption is based on the fact that there have been four M42s removed from the area in the past.

47. The M42 is a DP grenade or bomblet designed as a ground burst sub-munition containing 31 grams of explosive; with both the shaped charge and high fragmentation effects.

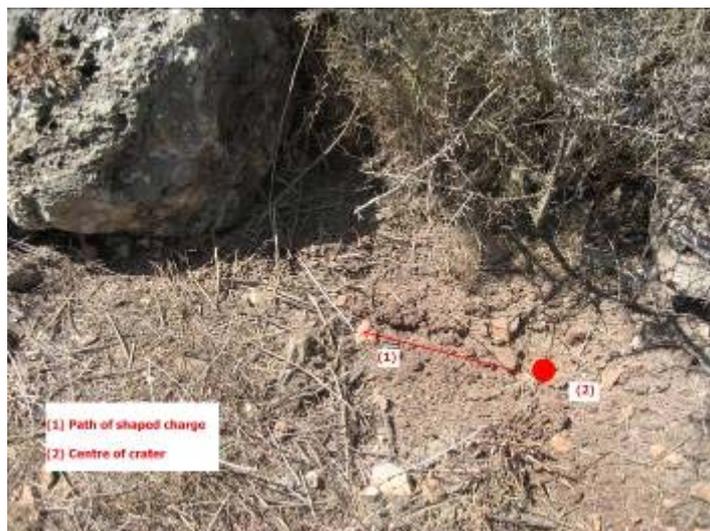
Photograph of Crater

48. Analysis of the crater suggests that the item was either partially or fully on the surface of the ground as with the majority of the items that have been found in the area. The crater clearly showed the path of the cone / shaped charge from the site of the detonation.
