DDAS Accident Report

Report date: 13/06/2008	Accident number: 578
Accident time: 10:50	Accident Date: 22/08/2005
Where it occurred: SS 19, Nimule to Juba Road, Lokichokio	Country: Sudan
Primary cause: Management/control inadequacy (?)	Secondary cause: Inadequate training (?)
Class: Missed-mine accident	Date of main report: 26/08/2005
ID original source: None	Name of source: UNMAO Sudan
Organisation: [Name removed]	
Mine/device: PMN AP blast	Ground condition: grass/grazing area route (verge) sparse trees
Date record created:	Date last modified: 13/06/2008
No of victims: 1	No of documents: 2

1.) Investigation of the mine accident [Demining group]

Missed mine investigation

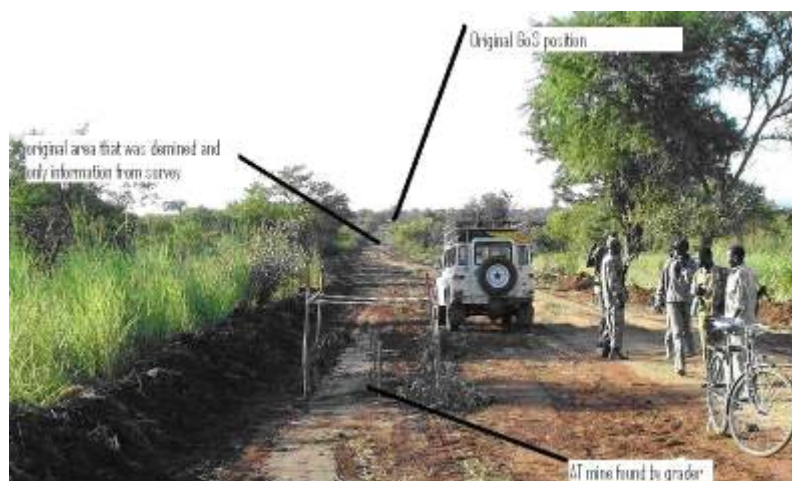
The incident site

Evidence on the ground: Flat, compact earth road graded by construction company. Areas to sides highly vegetated. Top of AT mine exposed and flush with road surface. Vehicle tracks to side of mine. [International Demining NGO] Operations Manager confirmed that the area had been cleared by [International Demining NGO] using BAC procedures. The mine was located 500 metres from the area where AT mines had been cleared by [International Demining NGO].

Chinese Type 72 Plastic AT mine which had been exposed by the grader at a depth of 25 cm. The mine was pulled, neutralized by removing the fuze/detonator and recovered to Moli. The mine was in good condition and there was no evidence of damage.

After handing over the area to the construction company a Grader was used for ground preparation to level the road to a depth of 60 cm. During this process the Grader uncovered a Type 72 AT mine at the edge of and within the cleared which was later confirmed to be at a depth of 25 cm to the top of the pressure plate. The road construction operations were immediately stopped and [International Demining NGO] were informed of the find. [International Demining NGO] asked the construction company to close and mark the site to prevent anyone moving through the site. An investigation by the [International Demining NGO] Operations Manager and UNSSRMAO QA Officer was conducted on 25 Aug 2005.

1. Conduct detailed investigation or BOI for [International demining NGO] incident 22 Aug 2005.
2. Clearance plan formulated by [International demining NGO] taking into account investigation or BOI findings and recommendations.
3. Detector trials to confirm whether [International demining NGO] mine clearance detectors area capable of locating Type 72 plastic AT mines at 25 cm.
