# DDAS Accident Report

<b>Report date:</b> 13/06/2008	<b>Accident number:</b> 578
<b>Accident time:</b> 10:50	<b>Accident Date:</b> 22/08/2005
<b>Where it occurred:</b> SS 19, Nimule to Juba Road, Lokichokkio	<b>Country:</b> Sudan
<b>Primary cause:</b> Management/control inadequacy (?)	<b>Secondary cause:</b> Inadequate training (?)
<b>Class:</b> Missed-mine accident	<b>Date of main report:</b> 26/08/2005
<b>ID original source:</b> None	<b>Name of source:</b> UNMAO Sudan
<b>Organisation:</b> [Name removed]	
<b>Mine/device:</b> PMN AP blast	<b>Ground condition:</b> grass/grazing area route (verge) sparse trees
<b>Date record created:</b>	<b>Date last modified:</b> 13/06/2008
<b>No of victims:</b> 1	<b>No of documents:</b> 2

## **1.) Investigation of the mine accident [Demining group]**

### Missed mine investigation

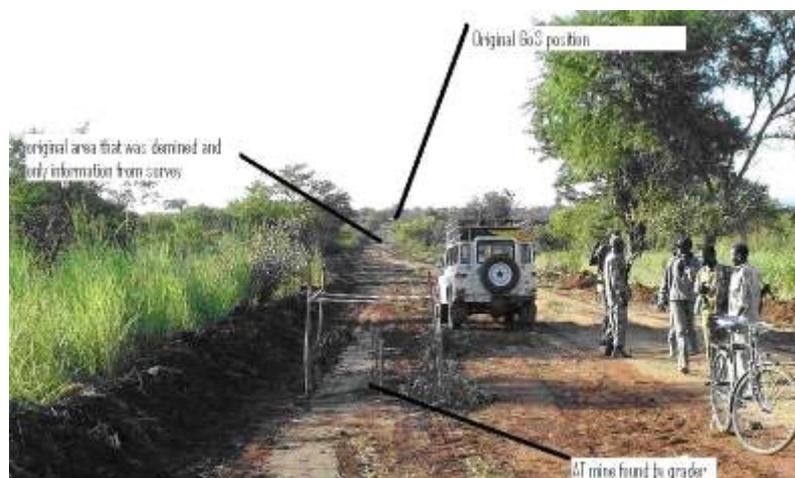
The incident site

A Type 72 plastic Anti Tank (AT) mine was discovered by the WFP contracted road construction company (GRZ) by a grading machine at a [International Demining NGO] road clearance task. The Task Dossier had been issued by the UNSSRMAO Rumbek.

Evidence on the ground: Flat, compact earth road graded by construction company. Areas to sides highly vegetated. Top of AT mine exposed and flush with road surface. Vehicle tracks to side of mine. [International Demining NGO] Operations Manager confirmed that the area had been cleared by [International Demining NGO] using BAC procedures. The mine was located 500 metres from the area where AT mines had been cleared by [International Demining NGO].

Chinese Type 72 Plastic AT mine which had been exposed by the grader at a depth of 25 cm. The mine was pulled, neutralized by removing the fuze/detonator and recovered to Moli. The mine was in good condition and there was no evidence of damage.
