# DDAS Accident Report

<b>Report date:</b> 14/06/2008	<b>Accident number:</b> 579
<b>Accident time:</b> 11:45	<b>Accident Date:</b> 26/11/2005
<b>Where it occurred:</b> Lutaya, 3.5 km West of Yei town	<b>Country:</b> Sudan
<b>Primary cause:</b> Field control inadequacy (?)	<b>Secondary cause:</b> Inadequate training (?)
<b>Class:</b> Excavation accident	<b>Date of main report:</b> 30/11/2005
<b>ID original source:</b> None	<b>Name of source:</b> UNMAO Sudan
<b>Organisation:</b> [Name removed]	
<b>Mine/device:</b> M14 AP blast	<b>Ground condition:</b> dry/dusty grass/grazing area hard metal fragments metal scrap
<b>Date record created:</b>	<b>Date last modified:</b> 14/06/2008
<b>No of victims:</b> 1	<b>No of documents:</b> 2

### **IMSMA Accident report**

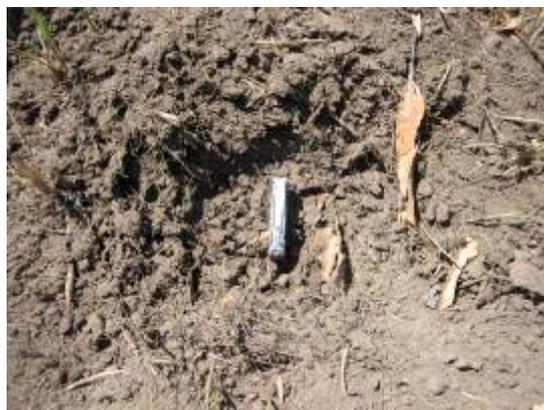
[Name removed] from UNMAS was informed 1 hour and 15 min after the time of the accident. He was taken to the accident site where he did his inquiries. The crater from the explosion is 30-40 cm away from the old crater. It is a small crater, 15 cm in diameter. The deminer's base stick was 20 cm behind the edge of the crater, one meter from the base lane. The handle of the deminers shovel was found 15m away from where he was working, the blade blown off. This confirms the deminer's story that he was excavating at the time of the accident. The size of the crater indicates a small AP blast mine. The blast has gone between the visor and the vest of the deminer.

Crater from detonation

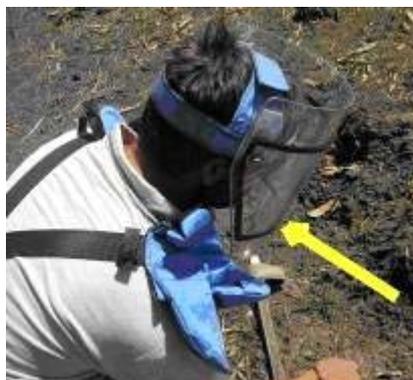
As for the facial injuries, a test done at the accident site show that it is possible to get a gap between the visor and the vest even if the PPE appears to be worn correctly.

Gap between visor and vest [See analysis]

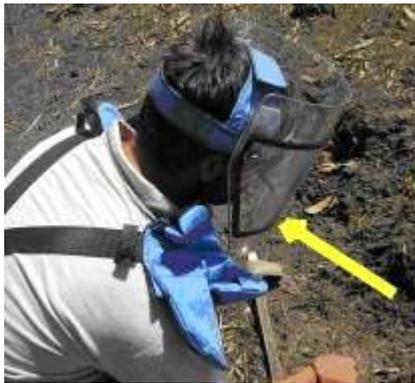
The supposed “proof” that environmental fragmentation could enter between the visor and the vest at an angle that allowed eyebrow injury while wearing the visor correctly illustrates the internal investigator’s lack of understanding about blast events. When an AP blast mine detonation occurs while a deminer is kneeling and excavating, the environmental fragmentation (earth and mine casing) strikes the visor face marginally before the blast wave. The blast wave may raise the visor, but it follow the fragments. The fragmentation is tumbling in the air but has forward momentum. If it has enough momentum to cause injury, that momentum imposes a direction that prevents any fragment turning sharply and heading in an entirely different direction.

This picture was included in the report to show how fragments could get between the visor and the vest. In fact it illustrates how it could not.

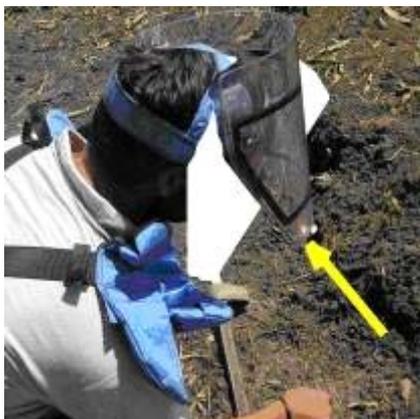
In order to strike the wearer’s face to the eyebrow, the deminer was wearing the visor raised in something more like this position. He was looking out from under it as he worked, and if he did not sustain eye injury that is because the M14 mine is very small (29g Tetryl) and he was lucky.
