DDAS Accident Report

Accident details

Report date: 21/06/2008	Accident number: 581
Accident time: 07:58	Accident Date: 21/11/2007
Where it occurred: MF: A-Kurmuk, M/F NR 91, DA NR 286.	Country: Sudan
Primary cause: Field control inadequacy (?)	Secondary cause: Management/control inadequacy (?)
Class: Missed-mine accident	Date of main report: 05/12/2007
ID original source: None	Name of source: UNMAO Sudan
Organisation: [Name removed]	
Mine/device: PRB M35 AP blast	Ground condition: bushes/scrub dry/dusty sparse trees
Date record created:	Date last modified: 21/06/2008
No of victims: 1	No of documents: 2

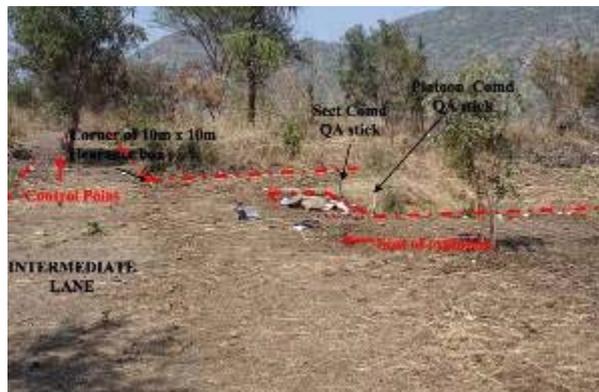
[The accident site after post-accident marking had been removed.]

Specific Geographic Information: The lay of the land at the scene of the accident finds it sloping away from the Control Point area in the west down towards the border in the east. The clearance activity was being conducted up the slope in an east to west direction. The immediate vicinity of the accident has been cleared of vegetation and provides unrestricted access. In the surrounding hazardous areas the vegetation is heavy. Underfoot the ground is firm in the cleared areas. The soil and surface conditions are typical for the area.

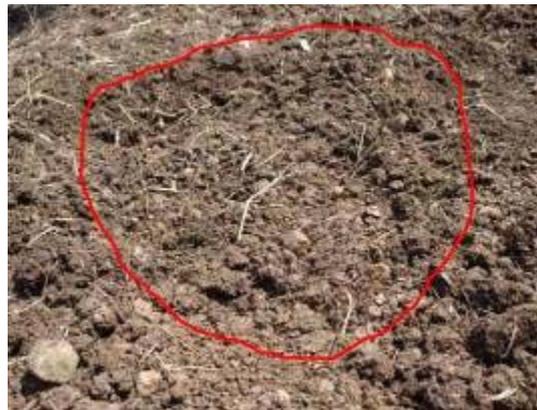
[The "crater" before excavation.]

The site was severely disrupted after the accident, presumably in the attempt to avoid censure. The disruption included moving the marking and the apparent levelling of the crater. AP mine blasts do not leave level loose ground that must be dug out to determine the depth of ground disturbance. Digging did not confirm the depth at which the mine had detonated. It did confirm that the undisturbed ground marked the depth of the original excavation, proving that the ground was not processed to the required depth during clearance. Because disturbed ground has more bulk than compacted ground, the actual depth of clearance was probably less than that measured.

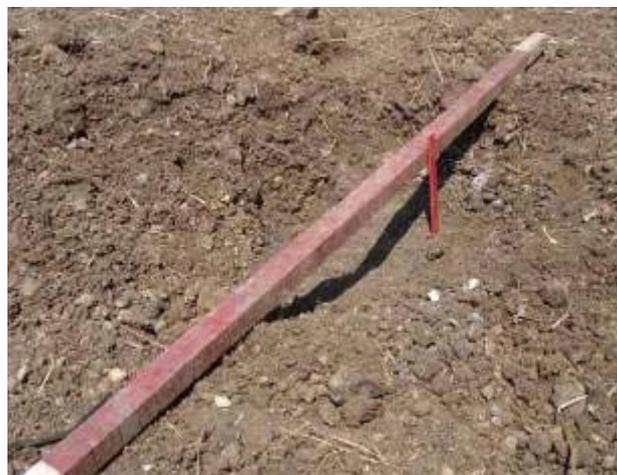
[The crater after excavation. See Analysis.]

4.1.1.2 That, from the investigation of the seat of the explosion, the floor of the crater caused by the explosion was at 18 cm below the surrounding ground level.

4.1.1.4 That, from an investigation of areas randomly chosen and within the immediate vicinity of the accident spot, required clearance depths were found to have been achieved i.e. 15cm.
