# DDAS Accident Report

<b>Report date:</b> 08/02/2011	<b>Accident number:</b> 597
<b>Accident time:</b>	<b>Accident Date:</b> 14/06/2010
<b>Where it occurred:</b> Kurmuk, Blue Nile State	<b>Country:</b> Sudan
<b>Primary cause:</b> Inadequate survey (?)	<b>Secondary cause:</b> Management/control inadequacy (?)
<b>Class:</b> Missed-mine accident	<b>Date of main report:</b>
<b>ID original source:</b> NR-553	<b>Name of source:</b> UNMAO
<b>Organisation:</b> [Name removed]	
<b>Mine/device:</b> M14 AP blast	<b>Ground condition:</b> grass/grazing area
<b>Date record created:</b>	<b>Date last modified:</b> 08/02/2011
<b>No of victims:</b> 0	<b>No of documents:</b> 1

United Nation Mine Action Office, Kurmuk 10/06/2006 Incident Report

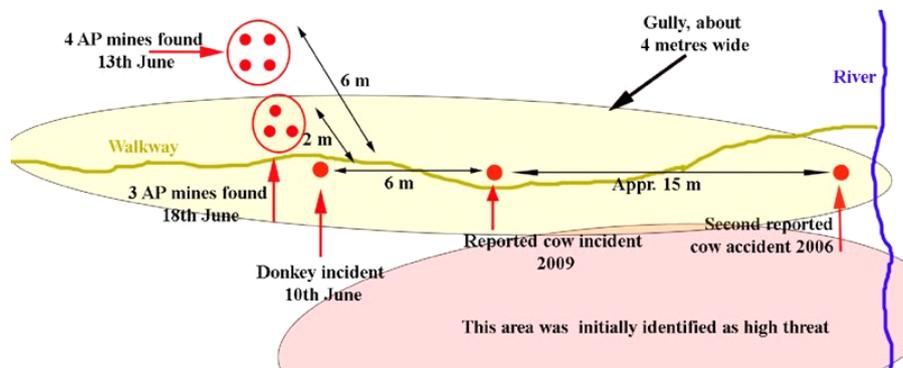
Figure 1: Schematic of the incident area and around it.

The gully where the incident took place has been used as a walk way for local people to collect water from the river, at the end of the gully. Near the river, a clear path could be seen where people would walk around to gain access to the river since the gully came to a sudden drop into the river and was too steep to walk down. The gully sides showed clear signs that over the years that water rushing down the gully had in time eroded the sides creating now what is a sizeable wide gully.

During the reconnaissance phase of task NR 553 in March 2010, [Four names removed] (IMCT team leader) stood at the river at the end of the gully and pointed out that a cow accident took place in the gully in 2009. A verbal decision was made that the gully was a high threat area along with the open area to the south-east of it.

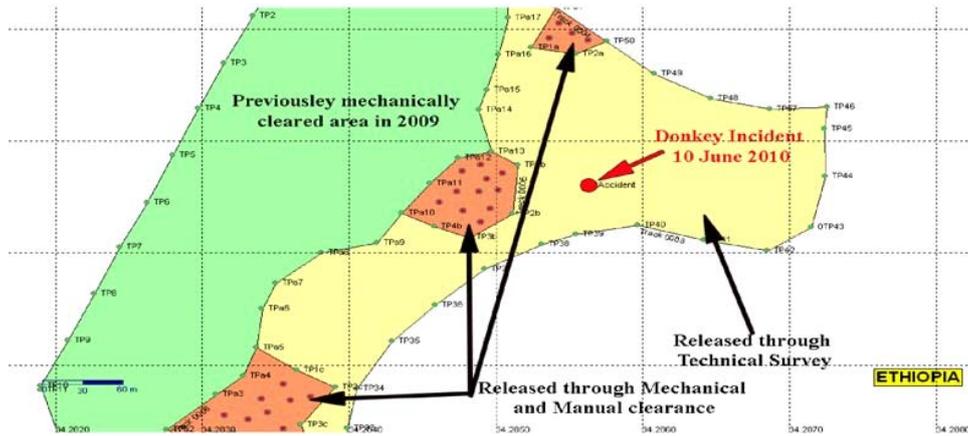
Figure 2: The completion map with areas marked as released through clearance (green and red) and released through technical survey (yellow)

The high threat flat area to the south east of the gully (see Figure 1 above) was cleared using the tiller of Armtrac 100 as was a flat area to the west of the gully. No mines or evidence of mine / ERW was found while operating the Armtrac in the flat areas above the gully. As a result, a decision was made [for Demining group] to release the land in the flat areas through technical survey in the completion report (see Figure 2).

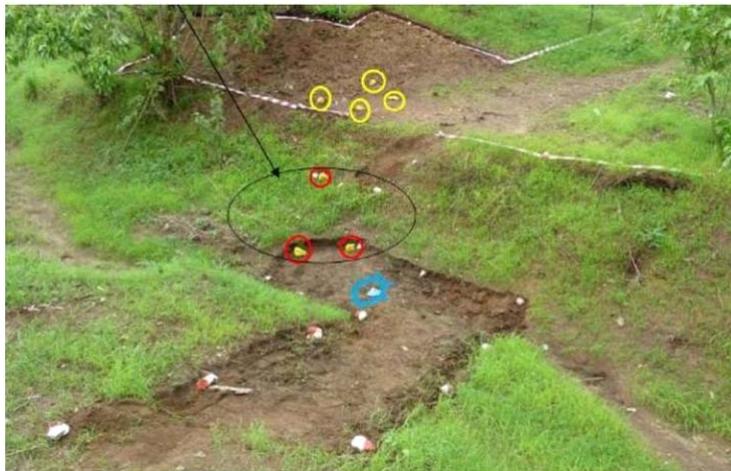
The floor of the gully was covered in silt but in the area where the detonation took place a number of large rocks could be seen sitting on a shoulder of silt at a greater height than the floor of the gully. There could be seen a line in the side of the gully of where recent erosion had taken place confirming that the water was eroding the gully sides with downwash of rain.

Picture 1: Photograph of the incident site with the donkey incident (blue) and seven mines (red and yellow circles) found during the subsequent clearance. Photo taken on 18th June 2010.

1.3 The accident area has been partially cleared during the initial clearance operations using a 1 metre MDD search lane going on the bottom of the gully. The entire gully has not been searched initially due to the misunderstanding of the MDD team leader and his failure to report and seek further advice from and the team managers. The fact that the gully has only

When the site was revisited again on Wednesday 16th June with the NMAC Damazin, [Demining group] and UNMAO Damazin personnel, changes were observed in the shape of the gully between the first visit on 14th June and 16th June. A serious rain storm on the night of the 15th June changed the shape and more erosion could be seen at the bottom of the gully.

2.8. It is recommended that [Demining group] continues clearing the area around the incident and the mines until they achieve 10 x 10 metres (as per the NSTGs Chapter 26 on Land

Release) around each mine found, and as per paragraph 4.2 above. The entire gulley shall be treated as a high threat area.
