DDAS Accident Report

INCIDENT INVESTIGATION FOR [demining group] – MINE ACTION TEAM - JORDAN

TASK NAME JABIR 3 (369B), NORTH BORDER PROJECT, EAST SECTOR

IMSMA DETAILED REPORT FOR MINE INCIDENT Monday, 1 Feb 2010

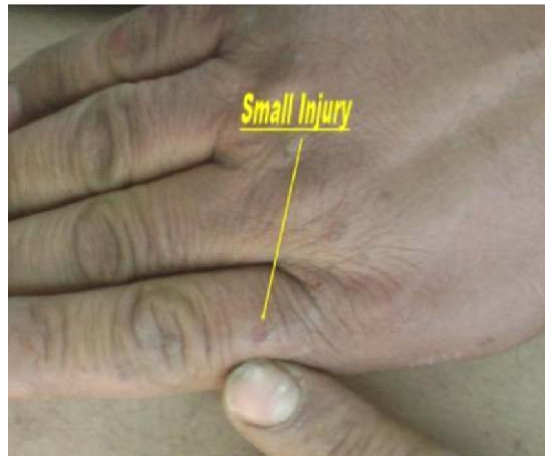
Injury

10. Did the incident result in any injuries? Yes.
11. List people injured and nature of injury: [Name removed, the Victim, deminer]: Multiple Superficial Scratches in his right hand.

INJURIES: minor Hand
