DDAS Accident Report

Report date: 05/03/2011	Accident number: 625
Accident time: 09:11	Accident Date: 07/04/2010
Where it occurred: MF 477, Jabir1, Jabir Village, Mafraq Province	Country: Jordan
Primary cause: Field control inadequacy (?)	Secondary cause: Unavoidable (?)
Class: Excavation accident	Date of main report: Not recorded
ID original source: None	Name of source: Demining group
Organisation: [Name removed]	
Mine/device: M14 AP blast	Ground condition: grass/grazing area hard rocks/stones
Date record created:	Date last modified: 05/03/2011
No of victims: 1	No of documents: 2

INCIDENT INVESTIGATION FOR [Demining group] – MINE ACTION TEAM - JORDAN

TASK NAME: JABIR 1 (477), NORTH BORDER PROJECT. EAST SECTOR

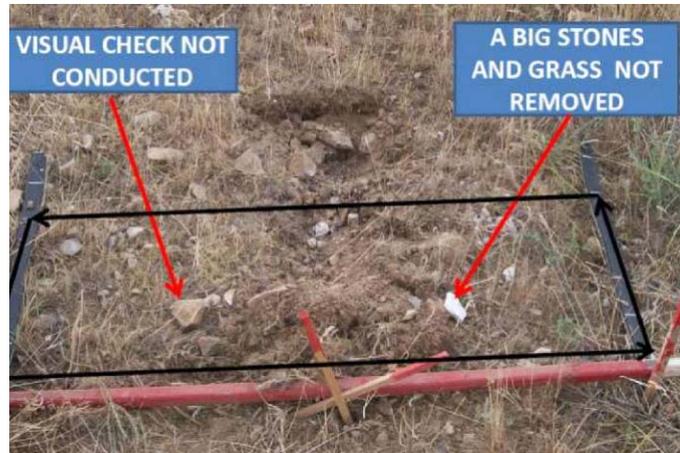
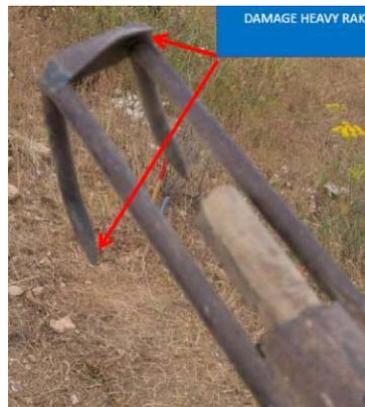
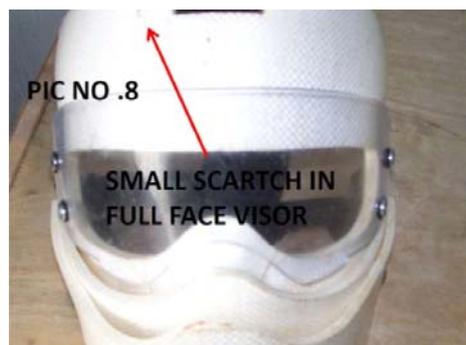
During the recovery of an AP mine the deminer hit the mine with heavy rake which initiate the mine and caused the incident.

17. Comments (include measurements of any crater resulting from the explosion): Crater
Depth: approx. 18 cm / Width: approx. 30 cm

1. The deminer didn't use the light rake.
2. He didn't make the visual check because there were stones in the clearance box.
3. The deminer checked the signal out of the box and it was 70 cm from the base stick.
4. The base stick is in the right place.

5. He didn't do the right procedures in cutting grass and removing loose stones according to the SOP.
6. The area is hard with lots of stones which mean to be careful in using the heavy rake.
7. The depth of crater is 18 cm and the mine was on 13 cm depth.
8. He started progressing from the right side then he took it from the front which is wrong and caused a mine blast.
9. The heavy rake has been damaged because of the blast.
10. The marking sticks are put in the right place according to SOP.

1. The Deminer didn't follow the right drill before searching the mine.(visual check and clearing the loose stones in the clearance box).
2. The area is grassy and hard hence light rake is not effective.
3. He shouldn't check beyond 50 cm from the base stick (one clearance box) but he extended the search up to 70cm.
4. The mine blast incident occurred due to the individual mistake of doing wrong drills.

It is strongly recommended to issue a written warning to the deminer for not following the right procedure and drill which resulted in the mine blast incident.
