DDAS Accident Report

Incident investigation [Demining group] – MINE ACTION TEAM - JORDAN

MINEFIELD NO – 365, minefield TASK ID- swailmeh 3

IMSMA DETAILED REPORT FOR MINE INCIDENT, Sunday, 11 July 2010

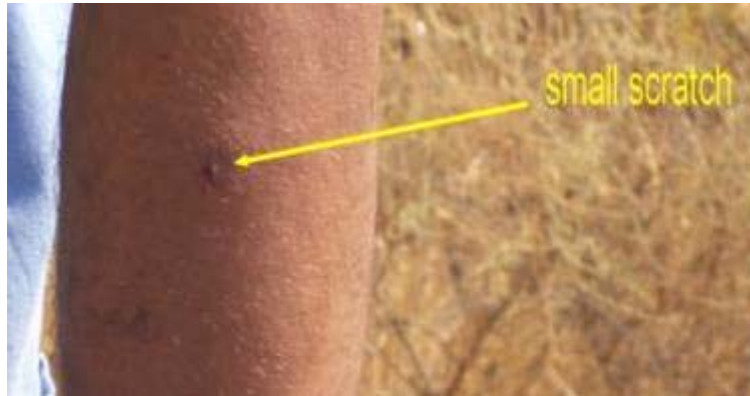
[The report included a photograph of a small scratch on the Victim's arm (he appears to have been working with his sleeves rolled up).]

INJURIES: minor Arm

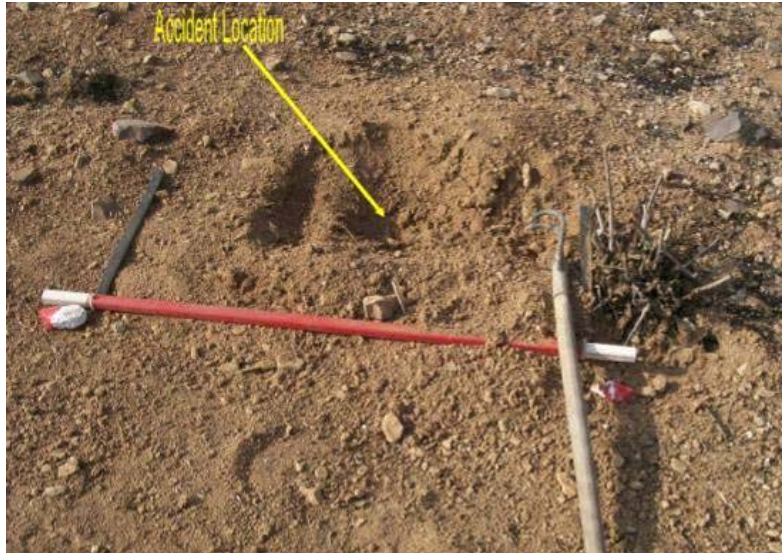
17. Comments (include measurements of any crater resulting from the explosion): Crater
Depth: approx. 20 cm / Width: approx. 40 cm

[The accident site.]

Marking system was not applied on the ground during approaching to the mine. Triangle marker drill was not applied on the ground during excavation. Guessing and scratching were noted on the ground around the incident area. Approaching to the mine was done from both sides, left and right

The photos and investigating the incident site shows that the deminer make some changes to the incident site (which is against the [Demining group]/NBP SOP) and a lack of supervision and control from the team leader.
