DDAS Accident Report

Report date: 07/03/2011	Accident number: 693
Accident time: 10:05	Accident Date: 26/07/2010
Where it occurred: Mf:411,, Sharajah 2, NW Sector, Ramtha Region	Country: Jordan
Primary cause: Field control inadequacy (?)	Secondary cause: Management/control inadequacy (?)
Class: Missed-mine accident	Date of main report: Not recorded
ID original source: None	Name of source: Demining group
Organisation: [Name removed]	
Mine/device: M14 AP blast	Ground condition: dry/dusty grass/grazing area rocks/stones soft
Date record created:	Date last modified: 07/03/2011
No of victims: 1	No of documents: 2

Incident investigation for [Demining group] – MINE ACTION TEAM - JORDAN

Task Name: shajarah 2 (411), north border project, NW SECTOR

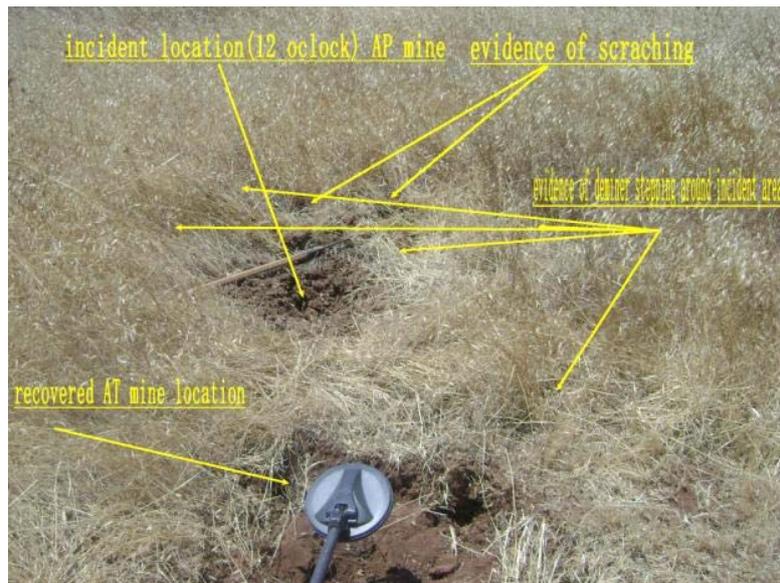
[The picture shows the detector in the foreground and a Heavy rake above the initiation site – so implying that the rake was in his hand at the time.]

Although the deminer may have had his detector in his hand at the time, the presence of the Heavy rake above the seat of the ignition, coupled with a lack of marking and a general disregard for the SOPs, suggest that this was a *Missed mine accident* and the Victim held the Heavy rake in his hand when he stepped on the mine.

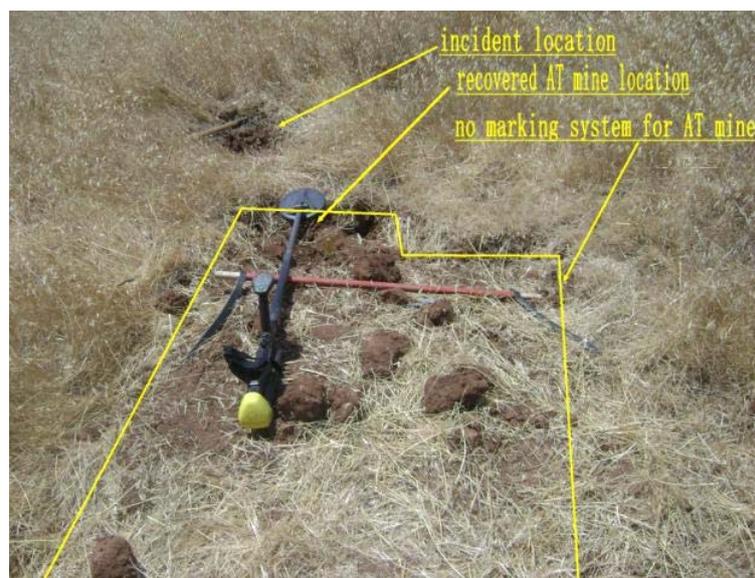
From the incident result it is clearly obvious that the mine was not buried deeper than 20 cm, which mean that using the MD with the combination method the mine will be located and recovered safely, the metal detector checked directly after the incident and it was operating properly, but its look like the deminer was applying one of the following scenarios:

The deminer was using the metal detector from a long distance away from the surface of the ground more than 10 cm (see the photo), the vegetation, the site of the incident crater support this scenario.

The deminer was not following the proper procedure and he tried to locate the mine by guessing using the heavy RAKE, finding the heavy RAKE in that distance away from the base stick supporting this scenario.
