DDAS Accident Report

File Reference: BOI 007/07

BAC INCIDENT REPORT 007/2007

Report on Incident that occurred on the 14th April 2007 at CBU 19, Area 4 Et Taibe.

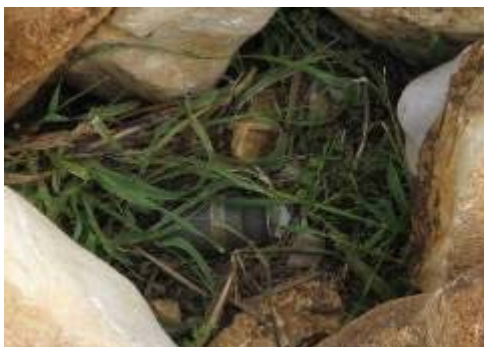
[The discovered submunition inside a ring of marking stones.]

- The sub-munition was clearly visible and showed no signs of being buried earlier.
- The sub-munition was not marked in accordance with [Demining group] SOP.
- The location of the sub-munition was in a visually searched area.

- The sub-munition was left unmarked from Saturday (14th April 2007) until being disposed Tuesday (17)
- It is inconclusive as to whether the sub-munition was not located during the clearance, or if the item has subsequently been delivered to the site after clearance.

The demining group marked the device by placing a ring of large stones around it. This is an effective informal marking system that is widely used and prevents people stepping on the item unintentionally. The investigators criticised them for not using the right marking without seeming to realise the purpose that marking serves.

- Regardless of when or where a situation like this occurs, the munition must be properly marked as per SOP and disposed of as soon as possible.
- Follow up clearance be conducted around the area of the location of the sub-munition.
- Revise visual clearance drills to confirm [Demining group] procedures.
